Access Compliance Report Public Rights-of-Way (Curb Ramps)

Intersection ID: 14793	Main Street: BALTIMORE_AV	Cross Street: BENJAMIN_ST	Location: E
ADA ID: 6882416CDA4D	Ramp Type: PerpDiag	Initial Pass/Fail: Fail	Overall Compliance: No Severity Score: 35

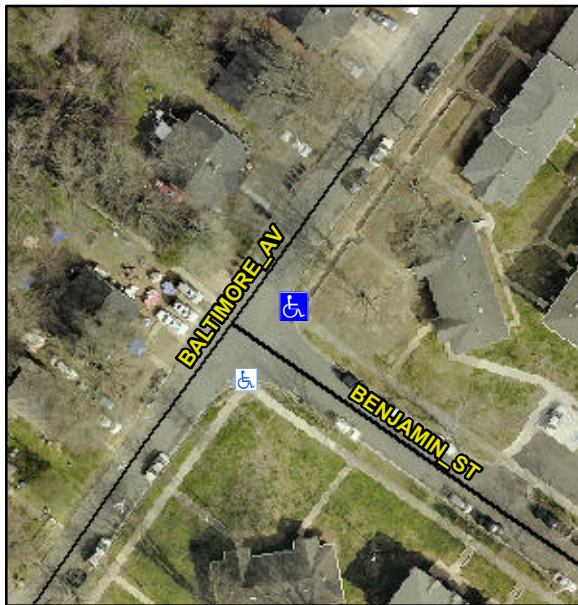
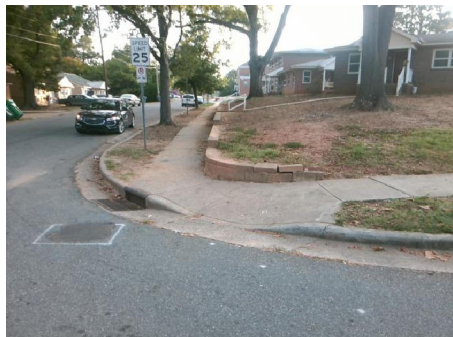
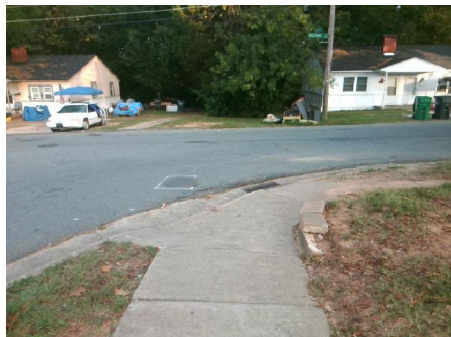
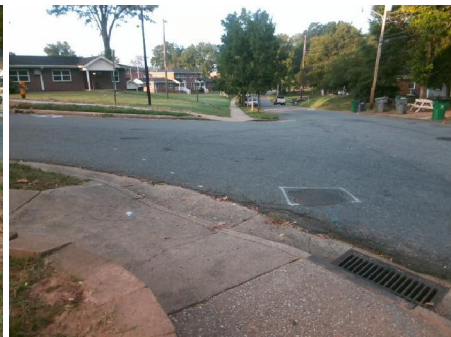
Not Found, R304.5.1, R304.2.2, R304.5.3

Compliance	Description	Data	Compliance	Description	Data
N/A	Ramp Length (in)	64.0	No	Ramp Slope (%)	15.4
No	Ramp Width (in)	38.0	No	Ramp XSlope (%)	2.8
N/A	Flare Type LT	N/A	N/A	Flare Type RT	N/A
N/A	Flare Slope LT (%)	N/A	N/A	Flare Slope RT (%)	N/A
N/A	Flare Traversable LT?	N/A	N/A	Flare Traversable RT?	N/A
N/A	Landing Length (in)	N/A	N/A	DWS Provided?	N/A
N/A	Landing Width (in)	N/A	N/A	DWS Contrast?	N/A
N/A	Landing Slope (%)	N/A	N/A	DWS Length (in)	N/A
N/A	Landing X Slope (%)	N/A	N/A	DWS Full Width?	N/A
N/A	Landing Curb? (Y/N)	N/A	N/A	DWS Offset (in)	N/A
N/A	Shared Landing?	N/A			
N/A	Gutter Ponding?	N/A	N/A	Gutter Slope (%)	N/A
N/A	Gutter Lip Ht (in)	N/A	N/A	Gutter X Slope (%)	N/A
N/A	Painted X Walk1?	No	N/A	Painted X Walk2?	No
	X Walk 1 Direction	To NW		X Walk 2 Direction	To SW
N/A	X Walk 1 Width (in)	N/A	N/A	X Walk 2 Width (in)	N/A
	X Walk 1 Slope (%)	4.9		X Walk 2 Slope (%)	0.2
	X Walk 1 X Slope (%)	1.9		X Walk 2 X Slope (%)	3.2

N/A	Ramp inside XWalk1?	N/A	N/A	Ramp inside XWalk2?	N/A
	Road Slope (%)	3.0	N/A	Clear Space?	N/A
	Road X Slope (%)	1.4	N/A	Clear Space to XWalk (in)	N/A
N/A	Any Obstructions?	N/A	N/A	Storm Grate/Utility Hazard?	N/A
	Obstruction Type			Storm Grate/Utility Type	
		N/A			N/A
			Yes	Surface Condition? (G/P)	Good

Remove & Replace Curb Ramp With Two New Directional Ramps or Equivalent.
