Access Compliance Report

Public Rights-of-Way

(Curb Ramps)

Intersection ID: 10027864	Main Street: HAMILTON_ST	Cross Street: N/A	Location: NW
ADA ID: 68843E175103	Ramp Type: Perp	Initial Pass/Fail: Fail	Overall Compliance: No
Severity Score: 13.75			
Codes/Mitigation Info/Possible Solution		Field Measurements/Component Compliance

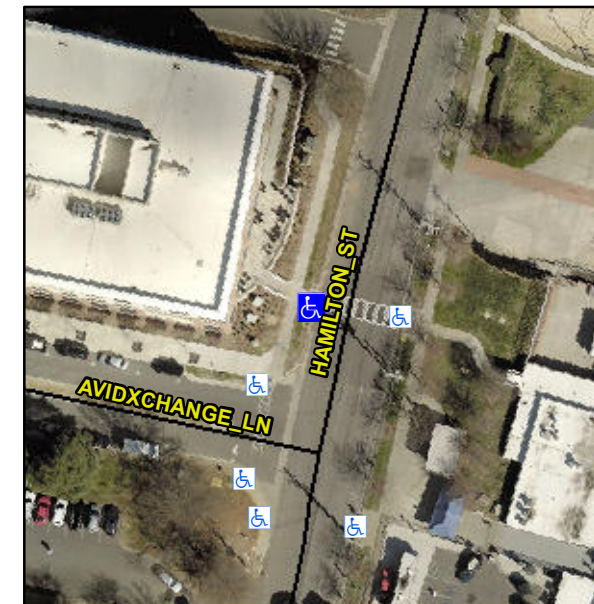
Compliance	Description	Data	Compliance	Description	Data
N/A	Ramp Length (in)	71.0	No	Ramp Slope (%)	9.9
Yes	Ramp Width (in)	72.0	Yes	Ramp XSlope (%)	2.9
N/A	Flare Type LT	N/A	N/A	Flare Type RT	N/A
N/A	Flare Slope LT (%)	N/A	N/A	Flare Slope RT (%)	N/A
N/A	Flare Traversable LT?	N/A	N/A	Flare Traversable RT?	N/A
N/A	Landing Length (in)	N/A	N/A	DWS Provided?	N/A
N/A	Landing Width (in)	N/A	N/A	DWS Contrast?	N/A
N/A	Landing Slope (%)	N/A	N/A	DWS Length (in)	N/A
N/A	Landing X Slope (%)	N/A	N/A	DWS Full Width?	N/A
N/A	Landing Curb? (Y/N)	N/A	N/A	DWS Offset (in)	N/A
N/A	Shared Landing?	N/A			
N/A	Gutter Ponding?	N/A	N/A	Gutter Slope (%)	N/A
N/A	Gutter Lip Ht (in)	N/A	N/A	Gutter X Slope (%)	N/A
N/A	Painted X Walk1?	Yes	N/A	Painted X Walk2?	N/A
	X Walk 1 Direction	To E		X Walk 2 Direction	N/A
N/A	X Walk 1 Width (in)	104.0	N/A	X Walk 2 Width (in)	N/A
	X Walk 1 Slope (%)	3.4		X Walk 2 Slope (%)	N/A
	X Walk 1 X Slope (%)	3.2		X Walk 2 X Slope (%)	N/A

N/A	Ramp inside XWalk1?	Yes	N/A	Ramp inside XWalk2?	N/A
	Road Slope (%)	N/A	N/A	Clear Space?	N/A
	Road X Slope (%)	N/A	N/A	Clear Space to XWalk (in)	N/A
N/A	Any Obstructions?	N/A	N/A	Storm Grate/Utility Hazard?	N/A
	Obstruction Type			Storm Grate/Utility Type	
		N/A			N/A
		Yes		Surface Condition? (G/P)	Good

Possible Solutions:

Remove & Replace Entire Ramp.
