Access Compliance Report

Public Rights-of-Way

(Curb Ramps)

Intersection ID: 10166	Main Street: OAKLAWN_AV	Cross Street: SPRING_ST	Location: SE
ADA ID: 68886605B9C5	Ramp Type: PerpDiag	Initial Pass/Fail: Fail	Overall Compliance: No
Severity Score: 25			
Codes/Mitigation Info/Possible Solution		Field Measurements/Component Compliance

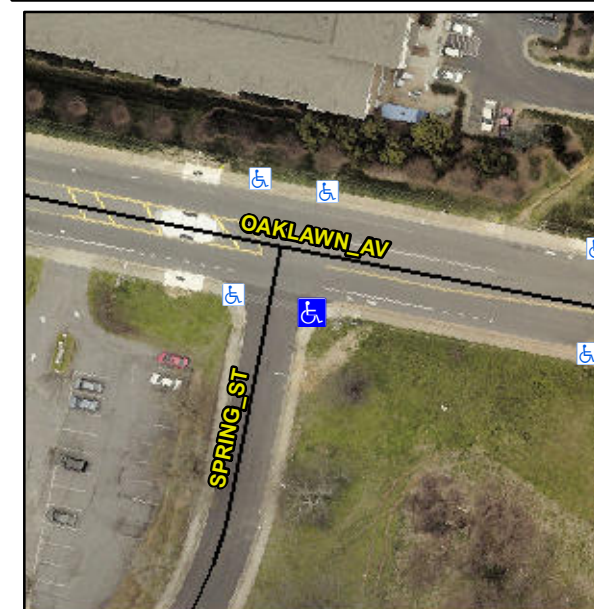
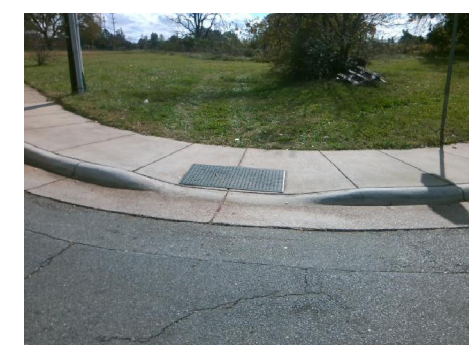
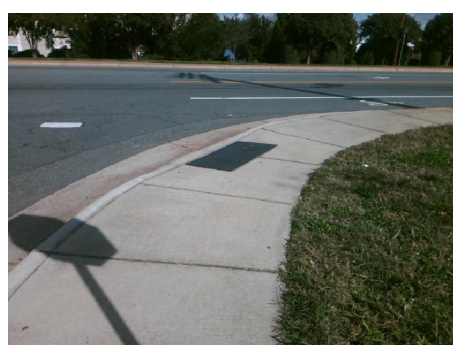
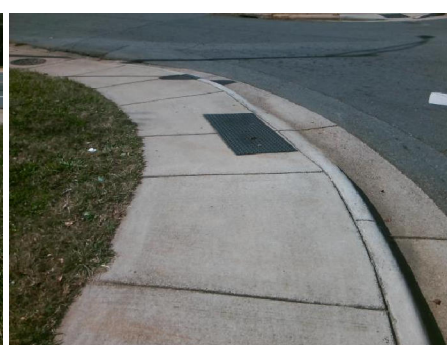
Not Found, R304.2.2, R304.5.3

Compliance	Description	Data	Compliance	Description	Data
N/A	Ramp Length (in)	60.0	No	Ramp Slope (%)	9.0
Yes	Ramp Width (in)	48.0	No	Ramp XSlope (%)	5.8
N/A	Flare Type LT	N/A	N/A	Flare Type RT	N/A
N/A	Flare Slope LT (%)	N/A	N/A	Flare Slope RT (%)	N/A
N/A	Flare Traversable LT?	N/A	N/A	Flare Traversable RT?	N/A
N/A	Landing Length (in)	N/A	N/A	DWS Provided?	N/A
N/A	Landing Width (in)	N/A	N/A	DWS Contrast?	N/A
N/A	Landing Slope (%)	N/A	N/A	DWS Length (in)	N/A
N/A	Landing X Slope (%)	N/A	N/A	DWS Full Width?	N/A
N/A	Landing Curb? (Y/N)	N/A	N/A	DWS Offset (in)	N/A
N/A	Shared Landing?	N/A			
N/A	Gutter Ponding?	N/A	N/A	Gutter Slope (%)	N/A
N/A	Gutter Lip Ht (in)	0.5	N/A	Gutter X Slope (%)	N/A
N/A	Painted X Walk1?	No	N/A	Painted X Walk2?	No
	X Walk 1 Direction	To N		X Walk 2 Direction	To W
N/A	X Walk 1 Width (in)	N/A	N/A	X Walk 2 Width (in)	N/A
	X Walk 1 Slope (%)	4.7		X Walk 2 Slope (%)	0.8
	X Walk 1 X Slope (%)	2.0		X Walk 2 X Slope (%)	5.0

N/A	Ramp inside XWalk1?	N/A	N/A	Ramp inside XWalk2?	N/A
	Road Slope (%)	1.8	N/A	Clear Space?	N/A
	Road X Slope (%)	2.1	N/A	Clear Space to XWalk (in)	N/A
N/A	Any Obstructions?	N/A	N/A	Storm Grate/Utility Hazard?	N/A
	Obstruction Type			Storm Grate/Utility Type	
		N/A			N/A
		Yes		Surface Condition? (G/P)	Good

Possible Solutions:

Remove & Replace Curb Ramp With Two New Directional Ramps or Equivalent.
