# Access Compliance Report

## Public Rights-of-Way

### (Curb Ramps)

| Intersection ID: N/A | Main Street: TAMARACK DR | Cross Street: SINGLELEAF LN | Location: N |

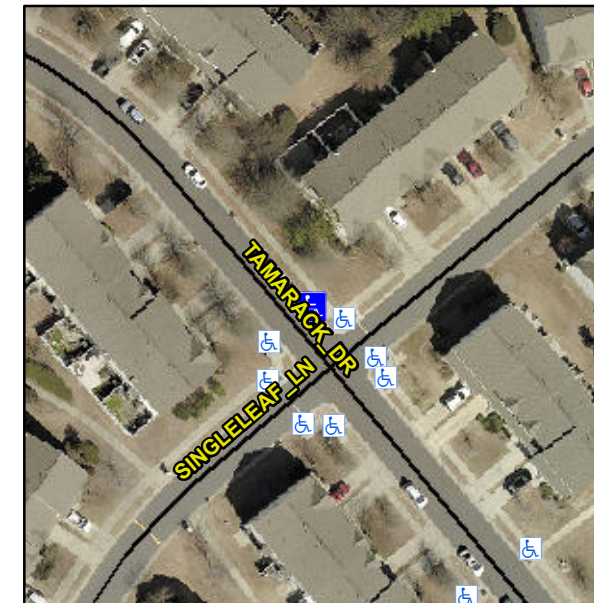
**N/A**

| Compliance | Description | Data | Compliance | Description | Data |
|---|---|---|---|---|---|
| N/A | Landing Curb? (Y/N) | No | No | DWS Offset (in) | 6.0 |
| Yes | Gutter Lip Ht (in) | 0.0 | No | Gutter X Slope (%) | 2.1 |

**Remove & Replace Detectable Warning System. Remove & Replace Gutter.**

**R305.2, R304.5.3**

Total Cost: \$ 1550.00
