Access Compliance Report

Public Rights-of-Way

(Curb Ramps)

Intersection ID: 10035419	Main Street: RANDOLPH_RD	Cross Street: N/A	Location: SE
ADA ID: 68A60C828001	Ramp Type: Perp	Initial Pass/Fail: Fail	Overall Compliance: No
Codes/Mitigation Info/Possible Solution		Field Measurements/Component Compliance	
Severity Score: 50

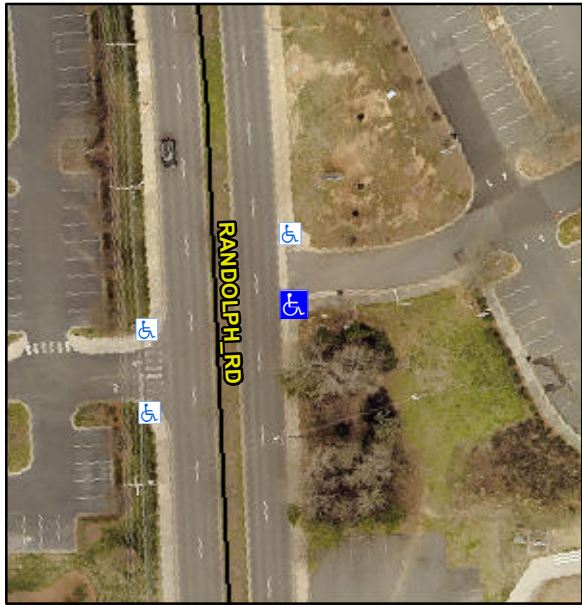
Compliance	Description	Data	Compliance	Description	Data
N/A	Ramp Length (in)	69.0	No	Ramp Slope (%)	12.7
Yes	Ramp Width (in)	48.0	No	Ramp XSlope (%)	9.6
N/A	Flare Type LT	N/A	N/A	Flare Type RT	N/A
N/A	Flare Slope LT (%)	N/A	N/A	Flare Slope RT (%)	N/A
N/A	Flare Traversable LT?	N/A	N/A	Flare Traversable RT?	N/A
N/A	Landing Length (in)	N/A	N/A	DWS Provided?	N/A
N/A	Landing Width (in)	N/A	N/A	DWS Contrast?	N/A
N/A	Landing Slope (%)	N/A	N/A	DWS Length (in)	N/A
N/A	Landing X Slope (%)	N/A	N/A	DWS Full Width?	N/A
N/A	Landing Curb? (Y/N)	N/A	N/A	DWS Offset (in)	N/A
N/A	Shared Landing?	N/A			
N/A	Gutter Ponding?	N/A	N/A	Gutter Slope (%)	N/A
N/A	Gutter Lip Ht (in)	N/A	N/A	Gutter X Slope (%)	N/A
N/A	Painted X Walk1?	No	N/A	Painted X Walk2?	N/A
	X Walk 1 Direction	To N		X Walk 2 Direction	N/A
N/A	X Walk 1 Width (in)	N/A	N/A	X Walk 2 Width (in)	N/A
	X Walk 1 Slope (%)	2.8		X Walk 2 Slope (%)	N/A
	X Walk 1 X Slope (%)	10.5		X Walk 2 X Slope (%)	N/A

N/A	Ramp inside XWalk1?	N/A	N/A	Ramp inside XWalk2?	N/A
	Road Slope (%)	N/A	N/A	Clear Space?	N/A
	Road X Slope (%)	N/A	N/A	Clear Space to XWalk (in)	N/A
N/A	Any Obstructions?	N/A	N/A	Storm Grate/Utility Hazard?	N/A
	Obstruction Type			Storm Grate/Utility Type	
		N/A			N/A
			Yes	Surface Condition? (G/P)	Good

Possible Solutions:					
	Remove & Replace Entire Ramp.					
	Surveyor Notes:					
	N/A					
	PROW/ADA:					
	Not Found, R304.2.2, R304.5.3					
	Street 1 Name		ENTRANCE			
	Stop Condition-Street 2		StopSign			
	Street 2 Name		N/A			
	Stop Condition-Street 1		N/A			
Total Cost:		\$	1850.00
