# Access Compliance Report

## Public Rights-of-Way

### (Curb Ramps)

| Intersection ID: 49131 | Main Street: EWERT_CUT_LN | Cross Street: WILTSHIRE_RIDGE_RD | Location: S |

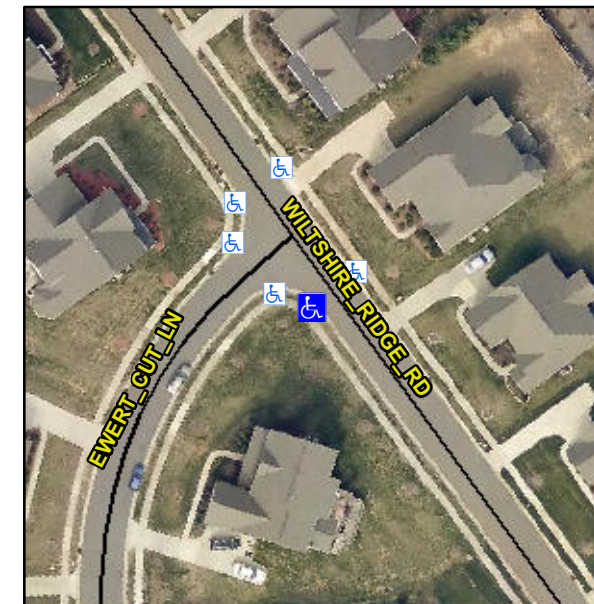
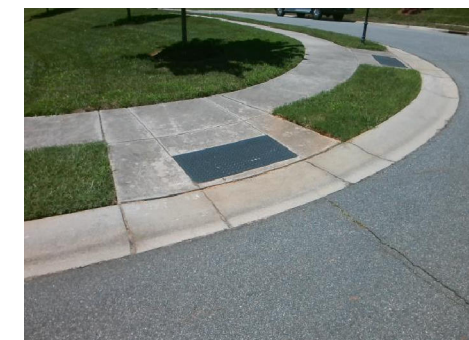
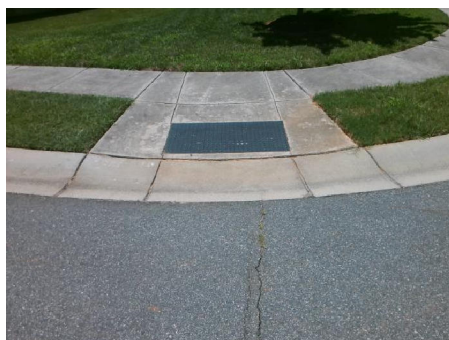
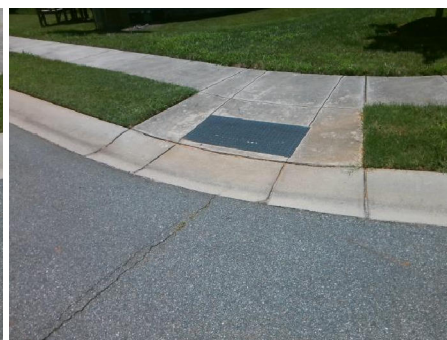
| ADA ID: 68B63FA76717 | Ramp Type: Perp | Initial Pass/Fail: Pass | Overall Compliance: No |
| Severity Score: 5.25 | | | |

**Not Found, R304.5.3, R304.2.2-Perp, R304.3.2-Para, R304.2.3, R305.2**

| Compliance | Description | Data | Compliance | Description | Data |
|---|---|---|---|---|---|
| Yes | Ramp Width (in) | 48.0 | No | Ramp XSlope (%) | 4.8 |
| N/A | Flare Slope LT (%) | 3.1 | No | Flare Slope RT (%) | 12.3 |
| No | Landing Slope (%) | 2.5 | Yes | DWS Length (in) | 24.5 |
| N/A | Landing Curb? (Y/N) | No | No | DWS Offset (in) | 4.0 |

**Remove & Replace Entire Ramp.**

Total Cost: \$ 1850.00
