Access Compliance Report

Public Rights-of-Way

(Curb Ramps)

Intersection ID: 27486	Main Street: DOWINGTON_DR	Cross Street: HOLLYBUSH_LN	Location: NE
ADA ID: 68C4BBE0AAEA	Ramp Type: Perp	Initial Pass/Fail: Fail	Overall Compliance: No
		Severity Score: 25

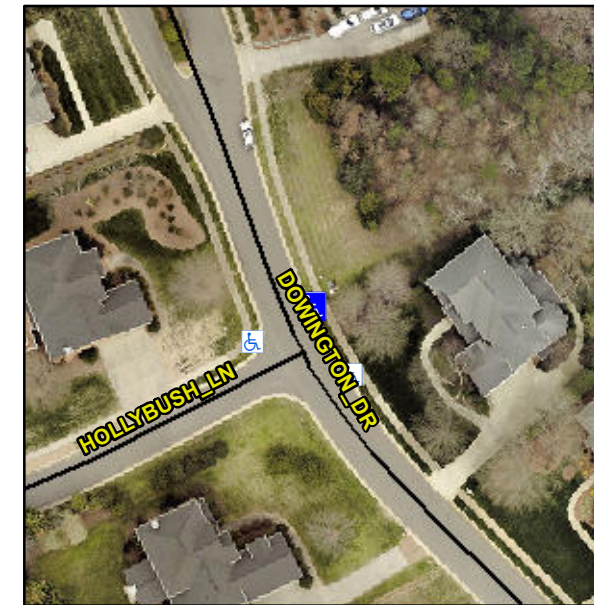
Not Found, R304.2.2, R304.5.3

Compliance	Description	Data	Compliance	Description	Data
N/A	Ramp Length (in)	48.0	No	Ramp Slope (%)	11.9
Yes	Ramp Width (in)	48.0	No	Ramp XSlope (%)	5.2
N/A	Flare Type LT	N/A	N/A	Flare Type RT	N/A
N/A	Flare Slope LT (%)	N/A	N/A	Flare Slope RT (%)	N/A
N/A	Flare Traversable LT?	N/A	N/A	Flare Traversable RT?	N/A
N/A	Landing Length (in)	N/A	N/A	DWS Provided?	N/A
N/A	Landing Width (in)	N/A	N/A	DWS Contrast?	N/A
N/A	Landing Slope (%)	N/A	N/A	DWS Length (in)	N/A
N/A	Landing X Slope (%)	N/A	N/A	DWS Full Width?	N/A
N/A	Landing Curb? (Y/N)	N/A	N/A	DWS Offset (in)	N/A
N/A	Shared Landing?	N/A			
N/A	Gutter Ponding?	N/A	N/A	Gutter Slope (%)	N/A
N/A	Gutter Lip Ht (in)	N/A	N/A	Gutter X Slope (%)	N/A
N/A	Painted X Walk1?	No	N/A	Painted X Walk2?	N/A
	X Walk 1 Direction	To SW		X Walk 2 Direction	N/A
N/A	X Walk 1 Width (in)	N/A	N/A	X Walk 2 Width (in)	N/A
	X Walk 1 Slope (%)	2.9		X Walk 2 Slope (%)	N/A
	X Walk 1 X Slope (%)	3.3		X Walk 2 X Slope (%)	N/A

N/A	Ramp inside XWalk1?	N/A	N/A	Ramp inside XWalk2?	N/A
	Road Slope (%)	N/A	N/A	Clear Space?	N/A
	Road X Slope (%)	N/A	N/A	Clear Space to XWalk (in)	N/A
N/A	Any Obstructions?	N/A	N/A	Storm Grate/Utility Hazard?	N/A
	Obstruction Type			Storm Grate/Utility Type	
		N/A			N/A
			Yes	Surface Condition? (G/P)	Good

Remove & Replace Entire Ramp.

Total Cost: \$ 1850.00
