Access Compliance Report

Public Rights-of-Way

(Curb Ramps)

Intersection ID: 48578	Main Street: PLOTT_RD	Cross Street: MATLEA_CT	Location: NW
ADA ID: 68C9CD886A81	Ramp Type: Perp	Initial Pass/Fail: Fail	Overall Compliance: No
		Severity Score: 10

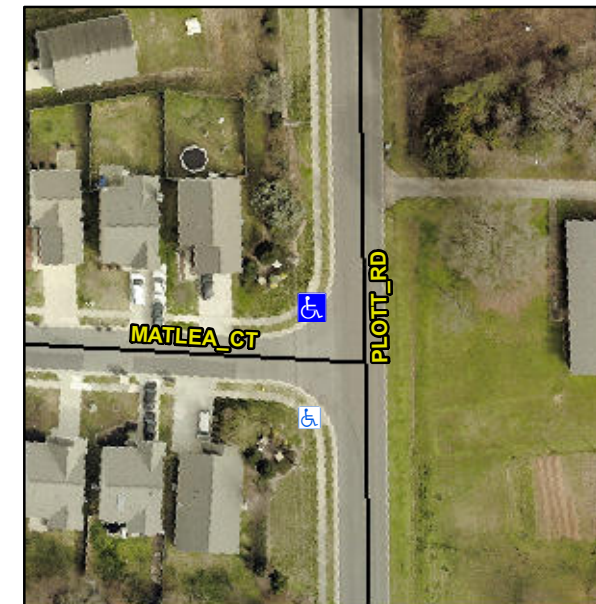
Not Found, R304.5.1, R304.5.3

Compliance	Description	Data	Compliance	Description	Data
N/A	Ramp Length (in)	45.0	Yes	Ramp Slope (%)	5.7
No	Ramp Width (in)	43.5	No	Ramp XSlope (%)	2.3
N/A	Flare Type LT	N/A	N/A	Flare Type RT	N/A
N/A	Flare Slope LT (%)	N/A	N/A	Flare Slope RT (%)	N/A
N/A	Flare Traversable LT?	N/A	N/A	Flare Traversable RT?	N/A
N/A	Landing Length (in)	N/A	N/A	DWS Provided?	N/A
N/A	Landing Width (in)	N/A	N/A	DWS Contrast?	N/A
N/A	Landing Slope (%)	N/A	N/A	DWS Length (in)	N/A
N/A	Landing X Slope (%)	N/A	N/A	DWS Full Width?	N/A
N/A	Landing Curb? (Y/N)	N/A	N/A	DWS Offset (in)	N/A
N/A	Shared Landing?	N/A			
N/A	Gutter Ponding?	N/A	N/A	Gutter Slope (%)	N/A
N/A	Gutter Lip Ht (in)	N/A	N/A	Gutter X Slope (%)	N/A
N/A	Painted X Walk1?	No	N/A	Painted X Walk2?	N/A
	X Walk 1 Direction	To S		X Walk 2 Direction	N/A
N/A	X Walk 1 Width (in)	N/A	N/A	X Walk 2 Width (in)	N/A
	X Walk 1 Slope (%)	1.0		X Walk 2 Slope (%)	N/A
	X Walk 1 X Slope (%)	1.3		X Walk 2 X Slope (%)	N/A

Remove & Replace Entire Ramp.
