Access Compliance Report

Public Rights-of-Way

(Curb Ramps)

Intersection ID: 10038044	Main Street: SHOPTON_RD	Cross Street: N/A	Location: S
ADA ID: 68CB65E649E9	Ramp Type: BlendTrans2	Initial Pass/Fail: Fail	Overall Compliance: No
		Severity Score: 25

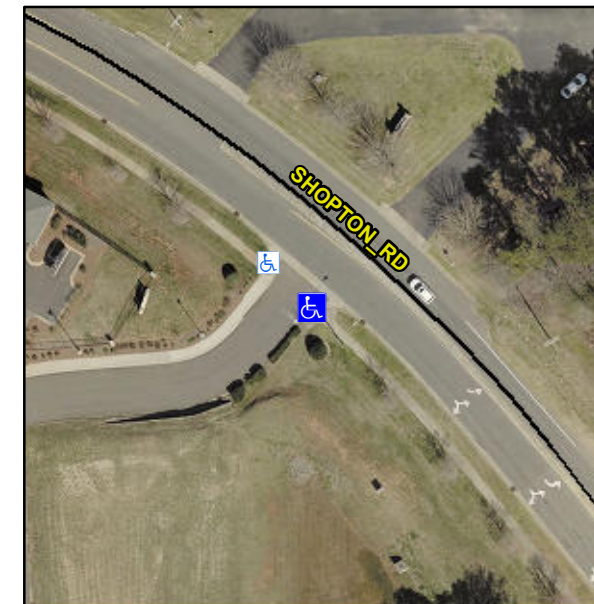
Compliance	Description	Data	Compliance	Description	Data
N/A	Ramp Length (in)	60.0	Yes	BlendTrans Slope (%)	2.0
Yes	Ramp Width (in)	48.0	No	BlendTrans XSlope (%)	14.9
N/A	Flare Type LT	N/A	N/A	Flare Type RT	N/A
N/A	Flare Slope LT (%)	N/A	N/A	Flare Slope RT (%)	N/A
N/A	Flare Traversable LT?	N/A	N/A	Flare Traversable RT?	N/A
N/A	Landing Length (in)	N/A	N/A	DWS Provided?	N/A
N/A	Landing Width (in)	N/A	N/A	DWS Contrast?	N/A
N/A	Landing Slope (%)	N/A	N/A	DWS Length (in)	N/A
N/A	Landing X Slope (%)	N/A	N/A	DWS Full Width?	N/A
N/A	Landing Curb? (Y/N)	N/A	N/A	DWS Offset (in)	N/A
N/A	Shared Landing?	N/A			
N/A	Gutter Ponding?	N/A	N/A	Gutter Slope (%)	N/A
N/A	Gutter Lip Ht (in)	N/A	N/A	Gutter X Slope (%)	N/A
N/A	Painted X Walk1?	No	N/A	Painted X Walk2?	No
	X Walk 1 Direction	To NE		X Walk 2 Direction	To NW
	X Walk 1 Width (in)	N/A		X Walk 2 Width (in)	N/A
	X Walk 1 Slope (%)	8.3		X Walk 2 Slope (%)	1.8
	X Walk 1 X Slope (%)	3.7		X Walk 2 X Slope (%)	7.0

N/A	Ramp inside XWalk1?	N/A	N/A	Ramp inside XWalk2?	N/A
	Road Slope (%)	8.4		Clear Space?	N/A
	Road X Slope (%)	0.8	N/A	Clear Space to XWalk (in)	N/A
N/A	Any Obstructions?	N/A	N/A	Storm Grate/Utility Hazard?	N/A
	Obstruction Type			Storm Grate/Utility Type	
		N/A			N/A
			Yes	Surface Condition? (G/P)	Good
			No	Curb Slope (%)	16.4

Possible Solutions:

Remove & Replace Curb Ramp With Two New Directional Ramps or Equivalent.

Not Found, R304.5.3

Total Cost: \$ 3200.00
