# Access Compliance Report

## Public Rights-of-Way

### (Curb Ramps)

Intersection ID: N/A	Main Street: KIMMERLY_GLEN_LN	Cross Street: ENDOLWOOD DR	Location: NE
ADA ID: 68DE68837990	Ramp Type: Directional1	Initial Pass/Fail: Fail	Overall Compliance: No
		Severity Score: 37.5

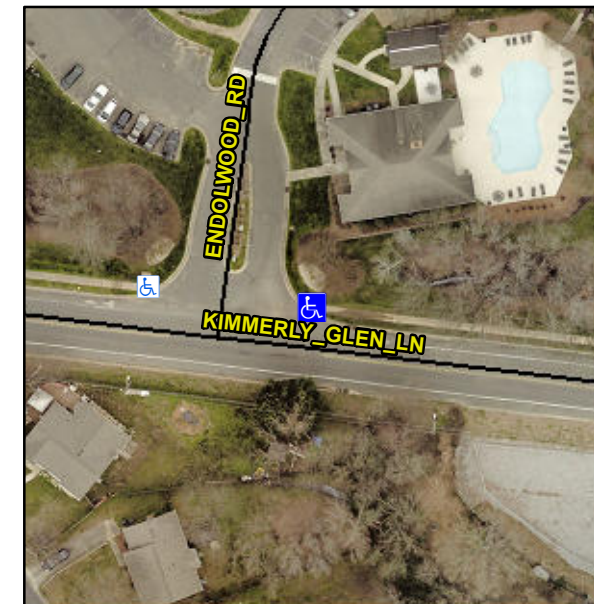
**DWS LCOATED ON LNDG**

Compliance	Description	Data	Compliance	Description	Data
N/A	Ramp Length (in)	38.0	N/A	Grade Break?	N/A
Yes	Ramp Width (in)	48.0	N/A	Grade Break Slope (%)	0.0
No	Ramp Slope (%)	10.0	N/A	Grade Break XSlope (%)	0.0
No	Ramp XSlope (%)	8.7			
N/A	Flare Type LT	N/A	N/A	Flare Type RT	N/A
N/A	Flare Slope LT (%)	N/A	N/A	Flare Slope RT (%)	0.0
N/A	Flare Traversable LT?	N/A	N/A	Flare Traversable RT?	N/A
N/A	Landing Length (in)	0.0	N/A	DWS Provided?	N/A
N/A	Landing Width (in)	0.0	N/A	DWS Contrast?	N/A
N/A	Landing Slope (%)	0.0	N/A	DWS Length (in)	N/A
N/A	Landing X Slope (%)	0.0	N/A	DWS Full Width?	N/A
N/A	Landing Curb? (Y/N)	N/A	N/A	DWS Offset LT (in)	N/A
N/A	Shared Landing?	N/A	N/A	DWS Offset RT (in)	N/A
N/A	Gutter Ponding?	0.0	N/A	Gutter Slope (%)	N/A
N/A	Gutter Lip Ht (in)	0.0	N/A	Gutter X Slope (%)	N/A
N/A	Painted X Walk1?	No		Road Slope (%)	3.1
	X Walk 1 Direction	To SW		Road X Slope (%)	0.5
	X Walk 1 Width (in)	N/A		Clear Space?	N/A

X Walk 1 Slope (%)	3.1	N/A	Clear Space to XWalk (in)	N/A
	X Walk 1 X Slope (%)	0.5	N/A	Storm Grate/Utility Hazard?	N/A
N/A	Ramp inside XWalk1?	N/A		Storm Grate/Utility Type	
N/A	Any Obstructions?	N/A			N/A
	Obstruction Type		Yes	Surface Condition? (G/P)	Good
			N/A	Curb Slope (%)	0.8

**Remove & Replace Entire Ramp.**
