Access Compliance Report

Public Rights-of-Way

(Curb Ramps)

Intersection ID: 31872	Main Street: LANGDEN_GATE_DR	Cross Street: TAPESTRY_WOODS_CT	Location: NE
ADA ID: 68E3676ED51E	Ramp Type: PerpDiag	Initial Pass/Fail: Fail	Overall Compliance: No
Codes/Mitigation Info/Possible Solution		Field Measurements/Component Compliance

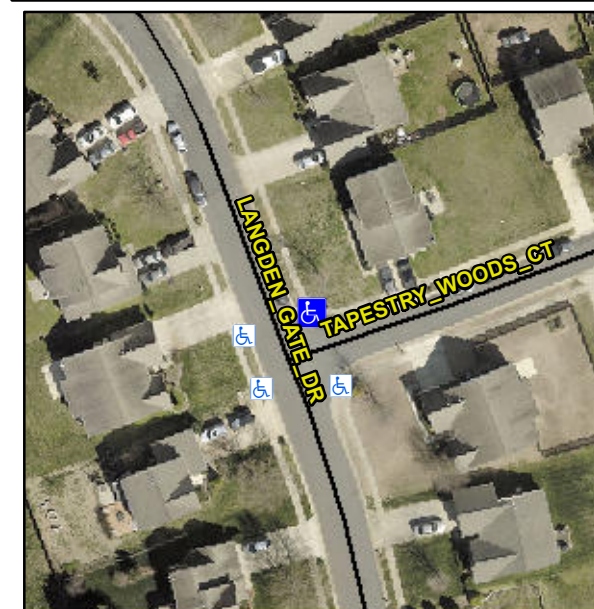
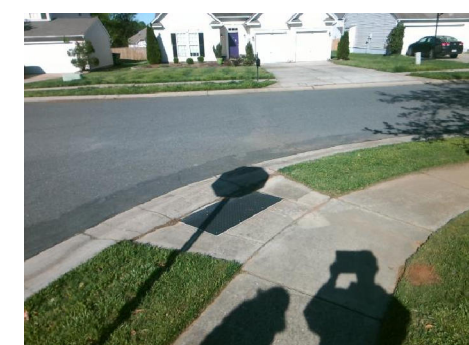
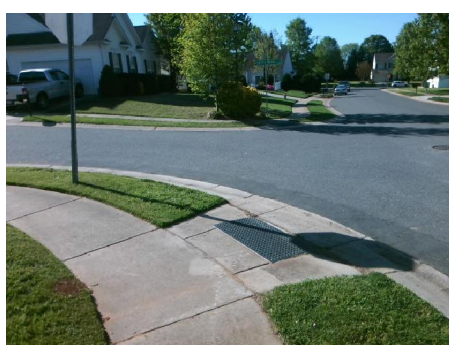
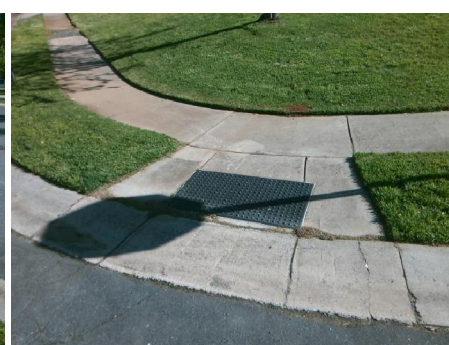
R304.5.1, R304.5.3

Compliance	Description	Data	Compliance	Description	Data
N/A	Ramp Length (in)	45.0	Yes	Ramp Slope (%)	6.8
No	Ramp Width (in)	38.0	No	Ramp XSlope (%)	2.6
N/A	Flare Type LT	N/A	N/A	Flare Type RT	N/A
N/A	Flare Slope LT (%)	N/A	N/A	Flare Slope RT (%)	N/A
N/A	Flare Traversable LT?	N/A	N/A	Flare Traversable RT?	N/A
N/A	Landing Length (in)	N/A	N/A	DWS Provided?	N/A
N/A	Landing Width (in)	N/A	N/A	DWS Contrast?	N/A
N/A	Landing Slope (%)	N/A	N/A	DWS Length (in)	N/A
N/A	Landing X Slope (%)	N/A	N/A	DWS Full Width?	N/A
N/A	Landing Curb? (Y/N)	N/A	N/A	DWS Offset (in)	N/A
N/A	Shared Landing?	N/A			
N/A	Gutter Ponding?	N/A	N/A	Gutter Slope (%)	N/A
N/A	Gutter Lip Ht (in)	N/A	N/A	Gutter X Slope (%)	N/A
N/A	Painted X Walk1?	No	N/A	Painted X Walk2?	No
	X Walk 1 Direction	To SW		X Walk 2 Direction	To SE
N/A	X Walk 1 Width (in)	N/A	N/A	X Walk 2 Width (in)	N/A
	X Walk 1 Slope (%)	1.3		X Walk 2 Slope (%)	0.7
	X Walk 1 X Slope (%)	0.1		X Walk 2 X Slope (%)	2.1

N/A	Ramp inside XWalk1?	N/A	N/A	Ramp inside XWalk2?	N/A
	Road Slope (%)	1.5	N/A	Clear Space?	N/A
	Road X Slope (%)	3.0	N/A	Clear Space to XWalk (in)	N/A
N/A	Any Obstructions?	N/A	N/A	Storm Grate/Utility Hazard?	N/A
	Obstruction Type			Storm Grate/Utility Type	
		N/A			N/A
			Yes	Surface Condition? (G/P)	Good

Remove & Replace Curb Ramp With Two New Directional Ramps or Equivalent.
