# Access Compliance Report

## Public Rights-of-Way (Curb Ramps)

| Intersection ID: 26209 | Main Street: CARMEL_RD | Cross Street: JOHNSTON_RD | Location: SW |
| ADA ID: 68E3AC657254 | Ramp Type: Perp | Initial Pass/Fail: Fail | Overall Compliance: No |

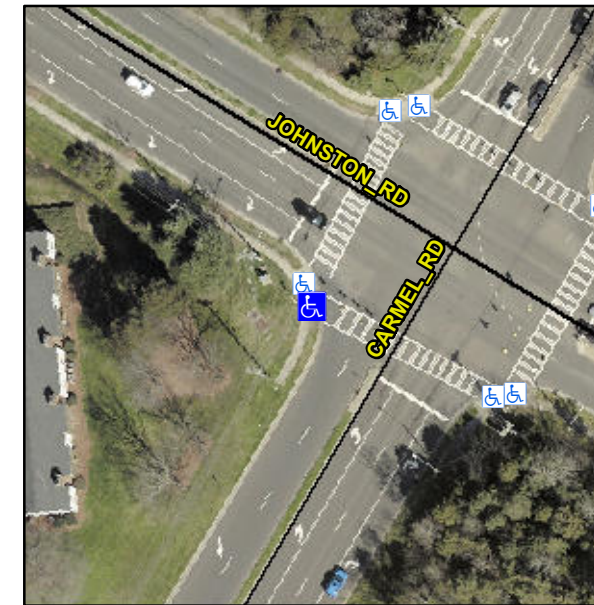
| | | Severity Score: 22.5 | |

**R304.5.1, R304.2.2, R304.5.3**

| Compliance | Description | Data | Compliance | Description | Data |
|---|---|---|---|---|---|
| N/A | Ramp Length (in) | 58.0 | No | Ramp Slope (%) | 9.6 |
| No | Ramp Width (in) | 42.0 | No | Ramp XSlope (%) | 2.2 |

**Remove & Replace Entire Ramp.**
