Access Compliance Report

Public Rights-of-Way

(Curb Ramps)

Intersection ID: 10041624	Main Street: WHITEHALL_EXECUTIVE_CENTER_DR	Cross Street: N/A	Location: NE
ADA ID: 68E915729041	Ramp Type: Perp	Initial Pass/Fail: Fail	Overall Compliance: No
Severity Score: 8.75			
Codes/Mitigation Info/Possible Solution		Field Measurements/Component Compliance

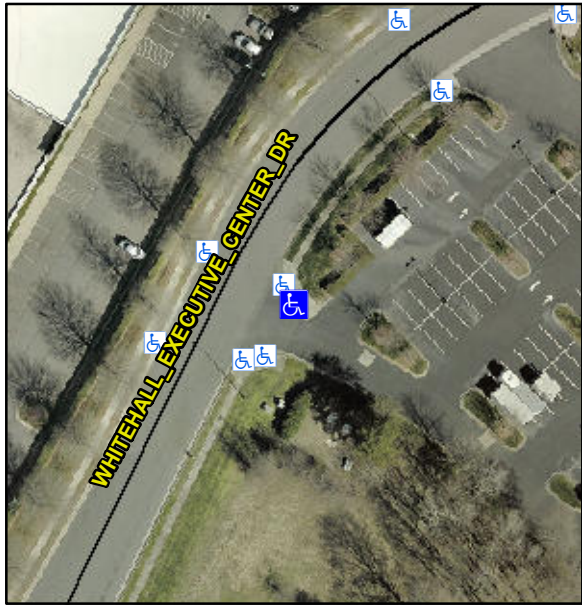
Not Found, R304.5.1

Compliance	Description	Data	Compliance	Description	Data
N/A	Ramp Length (in)	94.0	Yes	Ramp Slope (%)	7.7
No	Ramp Width (in)	41.0	Yes	Ramp XSlope (%)	0.0
N/A	Flare Type LT	N/A	N/A	Flare Type RT	N/A
N/A	Flare Slope LT (%)	N/A	N/A	Flare Slope RT (%)	N/A
N/A	Flare Traversable LT?	N/A	N/A	Flare Traversable RT?	N/A
N/A	Landing Length (in)	N/A	N/A	DWS Provided?	N/A
N/A	Landing Width (in)	N/A	N/A	DWS Contrast?	N/A
N/A	Landing Slope (%)	N/A	N/A	DWS Length (in)	N/A
N/A	Landing X Slope (%)	N/A	N/A	DWS Full Width?	N/A
N/A	Landing Curb? (Y/N)	N/A	N/A	DWS Offset (in)	N/A
N/A	Shared Landing?	N/A			
N/A	Gutter Ponding?	N/A	N/A	Gutter Slope (%)	N/A
N/A	Gutter Lip Ht (in)	N/A	N/A	Gutter X Slope (%)	N/A
N/A	Painted X Walk1?	No	N/A	Painted X Walk2?	N/A
	X Walk 1 Direction	To S		X Walk 2 Direction	N/A
N/A	X Walk 1 Width (in)	N/A	N/A	X Walk 2 Width (in)	N/A
	X Walk 1 Slope (%)	3.3		X Walk 2 Slope (%)	N/A
	X Walk 1 X Slope (%)	0.5		X Walk 2 X Slope (%)	N/A

N/A	Ramp inside XWalk1?	N/A	N/A	Ramp inside XWalk2?	N/A
	Road Slope (%)	N/A	N/A	Clear Space?	N/A
	Road X Slope (%)	N/A	N/A	Clear Space to XWalk (in)	N/A
N/A	Any Obstructions?	N/A	N/A	Storm Grate/Utility Hazard?	N/A
	Obstruction Type			Storm Grate/Utility Type	
		N/A			N/A
			Yes	Surface Condition? (G/P)	Good

Possible Solutions:

Remove & Replace Entire Ramp.

Total Cost:\$1850.00
