Access Compliance Report

Public Rights-of-Way

(Curb Ramps)

Intersection ID: 9432	Main Street: BEATTIES_FORD_RD	Cross Street: W_BROOKSHIRE_RA	Location: SW
ADA ID: 68EB61CFC75D	Ramp Type: Perp	Initial Pass/Fail: Fail	Overall Compliance: No
Severity Score: 12.5			
Codes/Mitigation Info/Possible Solution		Field Measurements/Component Compliance

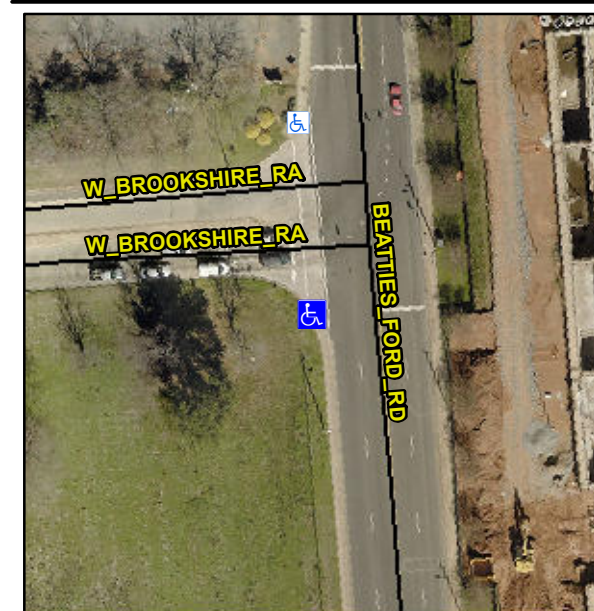
PROW/ADA:

Not Found, R304.2.2

Compliance	Description	Data	Compliance	Description	Data
N/A	Ramp Length (in)	59.5	No	Ramp Slope (%)	8.8
Yes	Ramp Width (in)	76.5	Yes	Ramp XSlope (%)	0.4
N/A	Flare Type LT	N/A	N/A	Flare Type RT	N/A
N/A	Flare Slope LT (%)	N/A	N/A	Flare Slope RT (%)	N/A
N/A	Flare Traversable LT?	N/A	N/A	Flare Traversable RT?	N/A
N/A	Landing Length (in)	N/A	N/A	DWS Provided?	N/A
N/A	Landing Width (in)	N/A	N/A	DWS Contrast?	N/A
N/A	Landing Slope (%)	N/A	N/A	DWS Length (in)	N/A
N/A	Landing X Slope (%)	N/A	N/A	DWS Full Width?	N/A
N/A	Landing Curb? (Y/N)	N/A	N/A	DWS Offset (in)	N/A
N/A	Shared Landing?	N/A			
N/A	Gutter Ponding?	N/A	N/A	Gutter Slope (%)	N/A
N/A	Gutter Lip Ht (in)	N/A	N/A	Gutter X Slope (%)	N/A
N/A	Painted X Walk1?	No	N/A	Painted X Walk2?	N/A
	X Walk 1 Direction	To N		X Walk 2 Direction	N/A
N/A	X Walk 1 Width (in)	N/A	N/A	X Walk 2 Width (in)	N/A
	X Walk 1 Slope (%)	2.7		X Walk 2 Slope (%)	N/A
	X Walk 1 X Slope (%)	2.7		X Walk 2 X Slope (%)	N/A

N/A	Ramp inside XWalk1?	N/A	N/A	Ramp inside XWalk2?	N/A
	Road Slope (%)	N/A	N/A	Clear Space?	N/A
	Road X Slope (%)	N/A	N/A	Clear Space to XWalk (in)	N/A
N/A	Any Obstructions?	N/A	N/A	Storm Grate/Utility Hazard?	N/A
	Obstruction Type			Storm Grate/Utility Type	
		N/A			N/A
		Yes		Surface Condition? (G/P)	Good

Possible Solutions:

Remove & Replace Entire Ramp.

Total Cost: \$ 1850.00
