# Access Compliance Report

## Public Rights-of-Way

### (Curb Ramps)

| Intersection ID: N/A | Main Street: PATIMBY_RD | Cross Street: MCALPINE_PARK_DR | Location: SW |

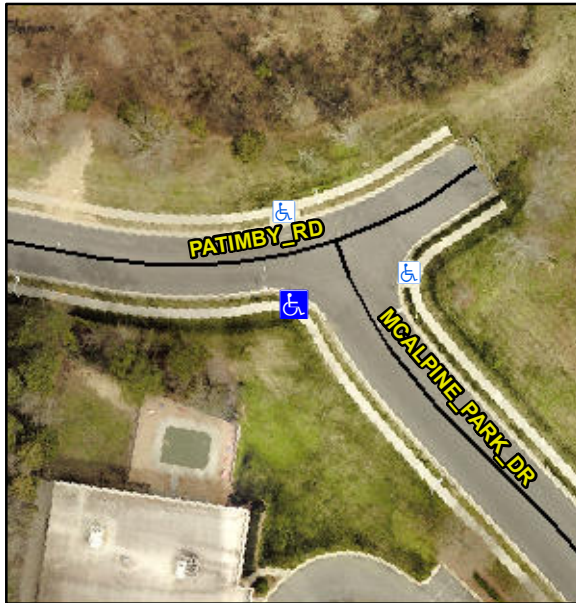
| ADA ID: 68F9EED696EF | Ramp Type: PerpDiag | Initial Pass/Fail: Fail | Overall Compliance: No |

**Not Found, R304.5.3**

| Compliance | Description | Data | Compliance | Description | Data |
|---|---|---|---|---|---|
| N/A | Ramp Length (in) | 48.0 | Yes | Ramp Slope (%) | 7.0 |
| Yes | Ramp Width (in) | 48.0 | No | Ramp XSlope (%) | 5.9 |

**Remove & Replace Curb Ramp With Two New Directional Ramps or Equivalent.**

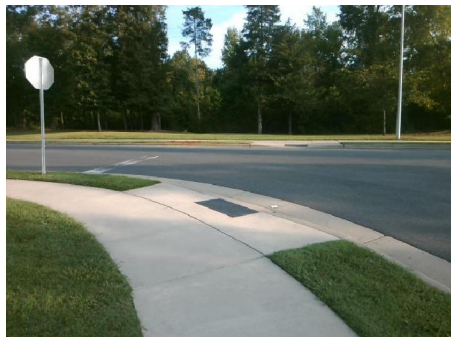
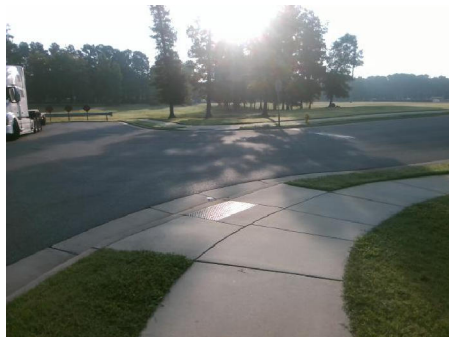
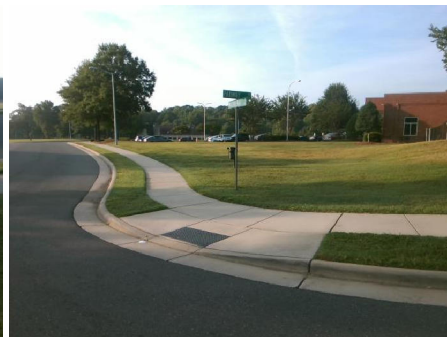
| Compliance | Description | Data | Compliance | Description | Data |
|---|---|---|---|---|---|
| | | Yes | | Surface Condition? (G/P) | Good |
