## Access Compliance Report Public Rights-of-Way (Curb Ramps)

Intersection ID: 9940 Main Street: KILDARE\_DR Cross Street: THE\_PLAZA Location: SW

ADA ID: 690797E3DC22 Ramp Type: PerpDiag Initial Pass/Fail: Fail Overall Compliance: No Severity Score: 12.5

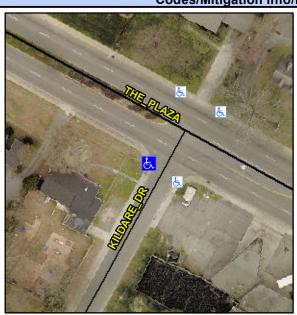
Not Found, R304.2.2

9	Complia	nce Description	Data	Compli	ance	Description	Data
1	N/A F	Ramp Length (in)	59.5	No	Ramp	Slope (%)	11.3
١	res F	Ramp Width (in)	48.0	Yes	Ramp	XSlope (%)	0.9
N	N/A	Flare Type LT	N/A	N/A	Flare	Type RT	N/A
1	N/A	Flare Slope LT (%)	N/A	N/A	Flare	Slope RT (%)	N/A
1	N/A i	Flare Traversable LT?	N/A	N/A	Flare	Traversable RT?	N/A
1	N/A L	Landing Length (in)	N/A	N/A	DWS	Provided?	N/A
1	N/A L	Landing Width (in)	N/A	N/A	DWS	Contrast?	N/A
1	N/A L	Landing Slope (%)	N/A	N/A	DWS	Length (in)	N/A
1	N/A L	Landing X Slope (%)	N/A	N/A	DWS	Full Width?	N/A
1	N/A L	Landing Curb? (Y/N)	N/A	N/A	DWS	Offset (in)	N/A
1	N/A S	Shared Landing?	N/A				
1	N/A	Gutter Ponding?	N/A	N/A	Gutte	r Slope (%)	N/A
N	N/A	Gutter Lip Ht (in)	N/A	N/A	Gutte	r X Slope (%)	N/A
1	N/A F	Painted X Walk1?	No	N/A	Painte	ed X Walk2?	No
	)	X Walk 1 Direction	To SE		X Wal	k 2 Direction	To NE
1	N/A	X Walk 1 Width (in)	N/A	N/A	X Wal	k 2 Width (in)	N/A
	)	X Walk 1 Slope (%)	3.7		X Wal	k 2 Slope (%)	2.6

)	X Walk 1 X Slope (%)	2.5		X Wal	k 2 X Slope (%)	2.7
1	N/A F	Ramp inside XWalk1?	N/A	N/A	Ramp	inside XWalk2?	N/A
	F	Road Slope (%)	1.0	N/A	Clear	Space?	N/A
	F	Road X Slope (%)	7.1	N/A	Clear	Space to XWalk (in)	N/A
1	N/A	Any Obstructions?	N/A	N/A	Storm	Grate/Utility Hazard?	N/A
	(	Obstruction Type			Storm	Grate/Utility Type	
			N/A				N/A

KILDARE DR StopSign THE PLAZA Remove & Replace Curb Ramp With Two New Directional Ramps or Equivalent.

Total Cost: \$ 3200.00
