# Access Compliance Report

## Public Rights-of-Way

### (Curb Ramps)

Intersection ID: 9865	Main Street: FREEDOM_DR	Cross Street: N_I-85_RA	Location:	N
ADA ID: 69096AE609F3	Ramp Type: Perp	Initial Pass/Fail: Fail	Overall Compliance: No	Severity Score: 21.25

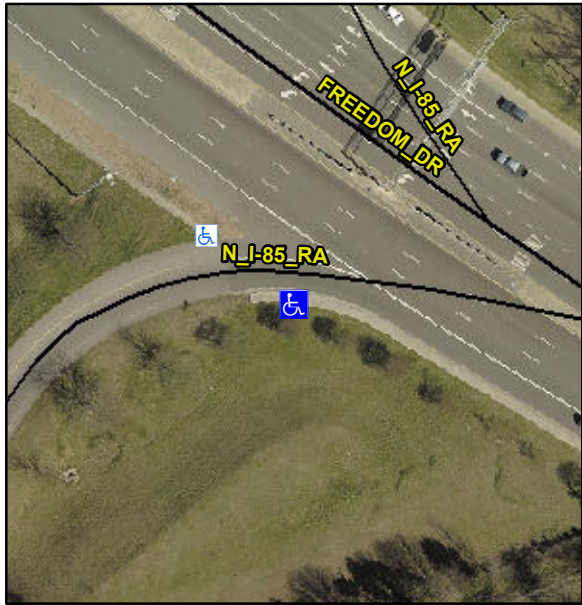
Possible Solutions:		Compliance	Description	Data	Compliance	Description	Data
	Remove & Replace Entire Ramp.		N/A	Ramp Length (in)	60.0	No	Ramp Slope (%)	9.8
			No	Ramp Width (in)	37.0	Yes	Ramp XSlope (%)	1.9
			N/A	Flare Type LT	N/A	N/A	Flare Type RT	N/A
			N/A	Flare Slope LT (%)	N/A	N/A	Flare Slope RT (%)	N/A
			N/A	Flare Traversable LT?	N/A	N/A	Flare Traversable RT?	N/A
			N/A	Landing Length (in)	N/A	N/A	DWS Provided?	N/A
			N/A	Landing Width (in)	N/A	N/A	DWS Contrast?	N/A
			N/A	Landing Slope (%)	N/A	N/A	DWS Length (in)	N/A
			N/A	Landing X Slope (%)	N/A	N/A	DWS Full Width?	N/A
Surveyor Notes:  N/A			N/A	Landing Curb? (Y/N)	N/A	N/A	DWS Offset (in)	N/A
			N/A	Shared Landing?	N/A			
			N/A	Gutter Ponding?	N/A	N/A	Gutter Slope (%)	N/A
			N/A	Gutter Lip Ht (in)	N/A	N/A	Gutter X Slope (%)	N/A
			N/A	Painted X Walk1?	No	N/A	Painted X Walk2?	N/A

X Walk 1 Direction	To N		X Walk 2 Direction	N/A
			N/A	X Walk 1 Width (in)	N/A	N/A	X Walk 2 Width (in)	N/A
				X Walk 1 Slope (%)	2.4		X Walk 2 Slope (%)	N/A
				X Walk 1 X Slope (%)	1.8		X Walk 2 X Slope (%)	N/A
			N/A	Ramp inside XWalk1?	N/A	N/A	Ramp inside XWalk2?	N/A
PROW/ADA:  Not Found, R304.5.1, R304.2.2				Road Slope (%)	N/A	N/A	Clear Space?	N/A
				Road X Slope (%)	N/A	N/A	Clear Space to XWalk (in)	N/A
			N/A	Any Obstructions?	N/A	N/A	Storm Grate/Utility Hazard?	N/A
				Obstruction Type			Storm Grate/Utility Type	
					N/A			N/A
						Yes	Surface Condition? (G/P)	Good
Total Cost:		\$	1850.00
