## Access Compliance Report Public Rights-of-Way (Curb Ramps)

Leastless	05		
Intersection ID: 50763	Main Street: QUIET_CREEK_CR			Cross	Cross Street: SCOTT_CREEK_DR				Location:	SE
ADA ID: 6909814A4098	8 Ramp Type: Perp			Initial	Initial Pass/Fail: Fail Overall Compliance: No				o Severity Score:	13.75
Codes/Mitigation Info/Possible Solution				Field Measurements/Component Compliance						
	10 10 10	Possible Solutions:			Compliance Description			Data Compliance Description		
		Remove & Replace Entit	re Ram	p.	N/A	Ramp Length (in)	47.5	No	Ramp Slope (%)	9.6
	Sist.			•	Yes	Ramp Width (in)	48.0	No	Ramp XSlope (%)	2.1

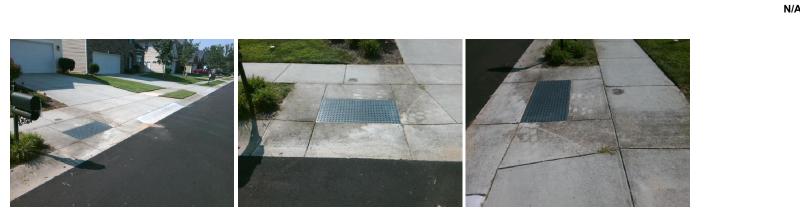
- ANTA	N/A			N/A	Landing Slope (%)	N/A	N/A	DWS Length (in)	N/A
	And the second				N/A	Landing X Slope (%)	N/A	N/A	DWS Full Width?	N/A
					N/A	Landing Curb? (Y/N)	N/A	N/A	DWS Offset (in)	N/A
					N/A	Shared Landing?	N/A			
1/1/ 000	1 1920	PROW/ADA:			N/A	Gutter Ponding?	N/A	N/A	Gutter Slope (%)	N/A
		Not Found, R304.2.2, R3	04.5.3		N/A	Gutter Lip Ht (in)	N/A	N/A	Gutter X Slope (%)	N/A
					N/A	Painted X Walk1?	No	N/A	Painted X Walk2?	N/A
	har					X Walk 1 Direction	To NW		X Walk 2 Direction	N/A
10 m Charles					N/A	X Walk 1 Width (in)	N/A	N/A	X Walk 2 Width (in)	N/A
Street 1 Name SCOTT C	REEK DR					X Walk 1 Slope (%)	1.3		X Walk 2 Slope (%)	N/A
Stop Condition-Street 2	None					X Walk 1 X Slope (%)	1.8		X Walk 2 X Slope (%)	N/A
Street 2 Name	N/A				N/A	Ramp inside XWalk1?	N/A	N/A	Ramp inside XWalk2?	N/A
Stop Condition-Street 1	N/A					Road Slope (%)	N/A	N/A	Clear Space?	N/A
						Road X Slope (%)	N/A	N/A	Clear Space to XWalk (in)	N/A

N/A	Any Obstructions?	N/A	N/A	Storm Grate/Utility Hazard?	N/A
		Total Cost:	\$	1850.00		Obstruction Type			Storm Grate/Utility Type	
							N/A			N/A
