## Access Compliance Report Public Rights-of-Way (Curb Ramps)

Intersection ID: 24242 Main Street: BEVERLY\_CREST\_BV Cross Street: PRESCOTT\_POND\_LN Location: N

ADA ID: 6913DEBD7755 Ramp Type: PerpDiag Initial Pass/Fail: Fail Overall Compliance: No Severity Score: 13.75

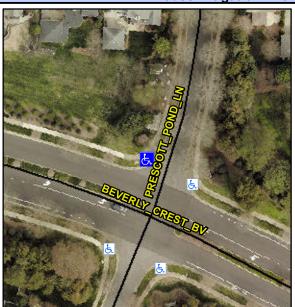
Not Found, R304.2.2, R304.5.3

Compliance Description Da		Data	Compliance Description		Data
N/A	Ramp Length (in)	96.0	No	Ramp Slope (%)	8.6
Yes	Ramp Width (in)	48.0	No	Ramp XSlope (%)	2.5
N/A	Flare Type LT	N/A	N/A	Flare Type RT	N/A
N/A	Flare Slope LT (%)	N/A	N/A	Flare Slope RT (%)	N/A
N/A	Flare Traversable LT?	N/A	N/A	Flare Traversable RT?	N/A
N/A	Landing Length (in)	N/A	N/A	DWS Provided?	N/A
N/A	Landing Width (in)	N/A	N/A	DWS Contrast?	N/A
N/A	Landing Slope (%)	N/A	N/A	DWS Length (in)	N/A
N/A	Landing X Slope (%)	N/A	N/A	DWS Full Width?	N/A
N/A	Landing Curb? (Y/N)	N/A	N/A	DWS Offset (in)	N/A
N/A	Shared Landing?	N/A			
N/A	Gutter Ponding?	N/A	N/A	Gutter Slope (%)	N/A
N/A	Gutter Lip Ht (in)	N/A	N/A	Gutter X Slope (%)	N/A
N/A	Painted X Walk1?	No	N/A	Painted X Walk2?	No
	X Walk 1 Direction	To SW		X Walk 2 Direction	To SE
N/A	X Walk 1 Width (in)	N/A	N/A	X Walk 2 Width (in)	N/A
	X Walk 1 Slope (%)	3.5		X Walk 2 Slope (%)	0.9
	X Walk 1 X Slope (%)	1.9		X Walk 2 X Slope (%)	6.4

N/A	Ramp inside XWalk1?	N/A	N/A	Ramp inside XWalk2?	N/A
	Road Slope (%)	4.8	N/A	Clear Space?	N/A
	Road X Slope (%)	3.7	N/A	Clear Space to XWalk (in)	N/A
N/A	Any Obstructions?	N/A	N/A	Storm Grate/Utility Hazard?	N/A
	Obstruction Type			Storm Grate/Utility Type	
		N/A			N/A

Remove & Replace Curb Ramp With Two New Directional Ramps or Equivalent.
