Access Compliance Report

Public Rights-of-Way

(Curb Ramps)

Intersection ID: N/A	Main Street: YOUNGBLOOD_ST	Cross Street: W_POINDEXTER_ST	Location: W
ADA ID: 691E0A541ECC	Ramp Type: Directional1	Initial Pass/Fail: Fail	Overall Compliance: No
		Severity Score: 1.25	
Codes/Mitigation Info/Possible Solution		Field Measurements/Component Compliance

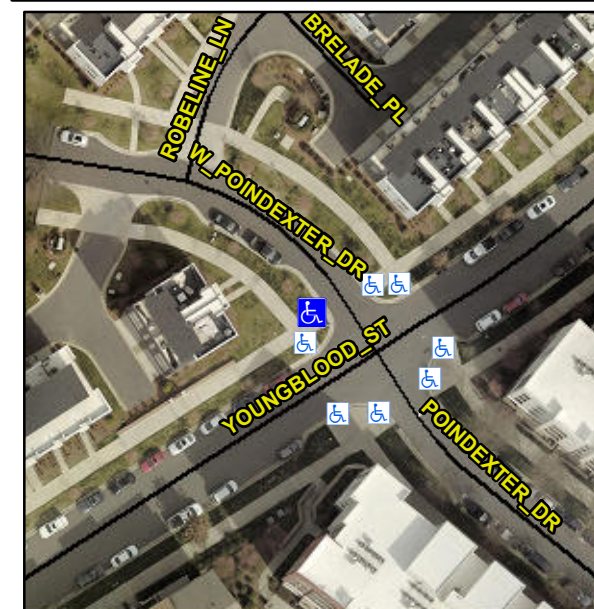
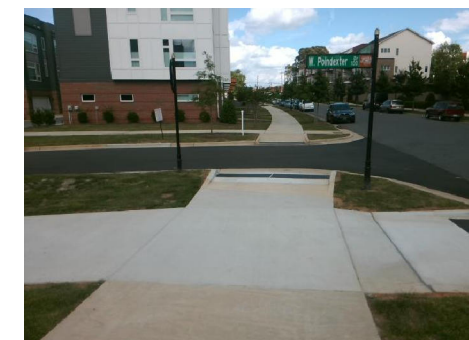
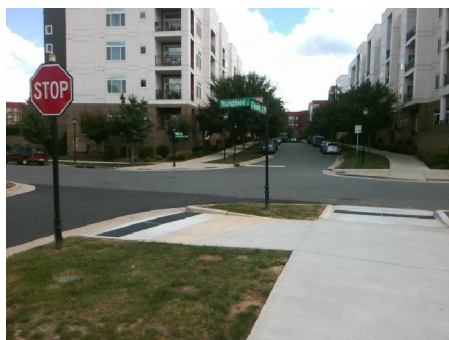
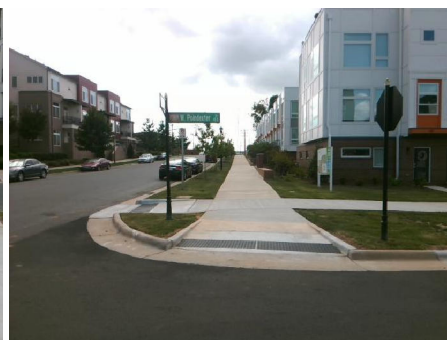
Compliance	Description	Data	Compliance	Description	Data
N/A	Ramp Length (in)	59.0	N/A	Grade Break?	N/A
Yes	Ramp Width (in)	96.0	N/A	Grade Break Slope (%)	0.0
Yes	Ramp Slope (%)	5.2	N/A	Grade Break XSlope (%)	0.0
No	Ramp XSlope (%)	2.6			
N/A	Flare Type LT	N/A	N/A	Flare Type RT	N/A
N/A	Flare Slope LT (%)	N/A	N/A	Flare Slope RT (%)	0.0
N/A	Flare Traversable LT?	N/A	N/A	Flare Traversable RT?	N/A
N/A	Landing Length (in)	0.0	N/A	DWS Provided?	N/A
N/A	Landing Width (in)	0.0	N/A	DWS Contrast?	N/A
N/A	Landing Slope (%)	0.0	N/A	DWS Length (in)	N/A
N/A	Landing X Slope (%)	0.0	N/A	DWS Full Width?	N/A
N/A	Landing Curb? (Y/N)	N/A	N/A	DWS Offset LT (in)	N/A
N/A	Shared Landing?	N/A	N/A	DWS Offset RT (in)	N/A
N/A	Gutter Ponding?	0.0	N/A	Gutter Slope (%)	N/A
N/A	Gutter Lip Ht (in)	0.0	N/A	Gutter X Slope (%)	N/A
N/A	Painted X Walk1?	No		Road Slope (%)	2.0
	X Walk 1 Direction	To NE		Road X Slope (%)	1.2
	X Walk 1 Width (in)	N/A		Clear Space?	N/A

X Walk 1 Slope (%)	2.0	N/A	Clear Space to XWalk (in)	N/A
	X Walk 1 X Slope (%)	1.2	N/A	Storm Grate/Utility Hazard?	N/A
N/A	Ramp inside XWalk1?	N/A		Storm Grate/Utility Type	
N/A	Any Obstructions?	N/A			N/A
	Obstruction Type		Yes	Surface Condition? (G/P)	Good
			N/A	Curb Slope (%)	14.6

Possible Solutions:

Remove & Replace Entire Ramp.

R304.5.3

Total Cost: \$ 1600.00
