# Access Compliance Report

## Public Rights-of-Way

### (Curb Ramps)

Intersection ID: 9810	Main Street: BRIDGEPORT_DR	Cross Street: THE_PLAZA	Location: NE
ADA ID: 69240875B4B0	Ramp Type: Perp	Initial Pass/Fail: Fail	Overall Compliance: No
Codes/Mitigation Info/Possible Solution		Field Measurements/Component Compliance	
Severity Score: 21.25

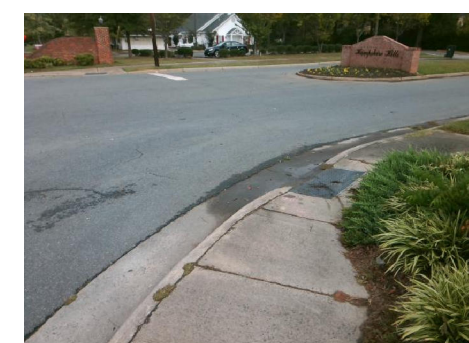
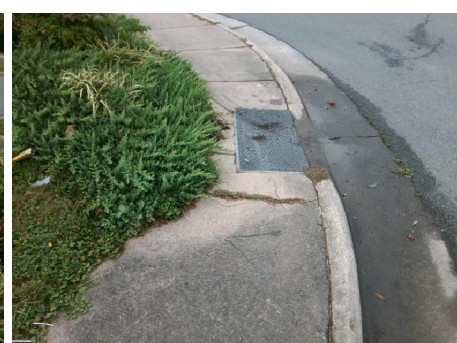
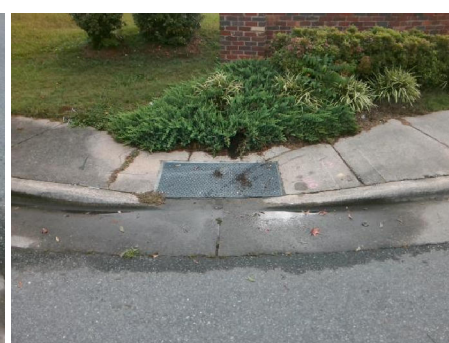
**R304.5.1, R304.2.2**

Compliance	Description	Data	Compliance	Description	Data
N/A	Ramp Length (in)	57.0	No	Ramp Slope (%)	11.0
No	Ramp Width (in)	47.5	Yes	Ramp XSlope (%)	1.3
N/A	Flare Type LT	N/A	N/A	Flare Type RT	N/A
N/A	Flare Slope LT (%)	N/A	N/A	Flare Slope RT (%)	N/A
N/A	Flare Traversable LT?	N/A	N/A	Flare Traversable RT?	N/A
N/A	Landing Length (in)	N/A	N/A	DWS Provided?	N/A
N/A	Landing Width (in)	N/A	N/A	DWS Contrast?	N/A
N/A	Landing Slope (%)	N/A	N/A	DWS Length (in)	N/A
N/A	Landing X Slope (%)	N/A	N/A	DWS Full Width?	N/A
N/A	Landing Curb? (Y/N)	N/A	N/A	DWS Offset (in)	N/A
N/A	Shared Landing?	N/A			
N/A	Gutter Ponding?	Yes	N/A	Gutter Slope (%)	N/A
N/A	Gutter Lip Ht (in)	N/A	N/A	Gutter X Slope (%)	N/A
N/A	Painted X Walk1?	No	N/A	Painted X Walk2?	N/A
	X Walk 1 Direction	To NW		X Walk 2 Direction	N/A
N/A	X Walk 1 Width (in)	N/A	N/A	X Walk 2 Width (in)	N/A
	X Walk 1 Slope (%)	0.4		X Walk 2 Slope (%)	N/A
	X Walk 1 X Slope (%)	2.1		X Walk 2 X Slope (%)	N/A

N/A	Ramp inside XWalk1?	N/A	N/A	Ramp inside XWalk2?	N/A
	Road Slope (%)	N/A	N/A	Clear Space?	N/A
	Road X Slope (%)	N/A	N/A	Clear Space to XWalk (in)	N/A
N/A	Any Obstructions?	N/A	N/A	Storm Grate/Utility Hazard?	N/A
	Obstruction Type			Storm Grate/Utility Type	
		N/A			N/A
		Yes		Surface Condition? (G/P)	Good

**Remove & Replace Entire Ramp.**

Total Cost: \$ 1850.00
