Access Compliance Report

Public Rights-of-Way

(Curb Ramps)

Intersection ID: 8816	Main Street: BROOKSTEAD MEADOW CT	Cross Street: NORKETT DR	Location: S
ADA ID: 692CB9F7C968	Ramp Type: PerpDiag	Initial Pass/Fail: Fail	Overall Compliance: No
Severity Score: 8.75			
Codes/Mitigation Info/Possible Solution		Field Measurements/Component Compliance

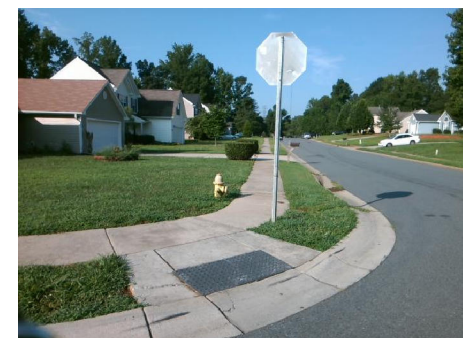
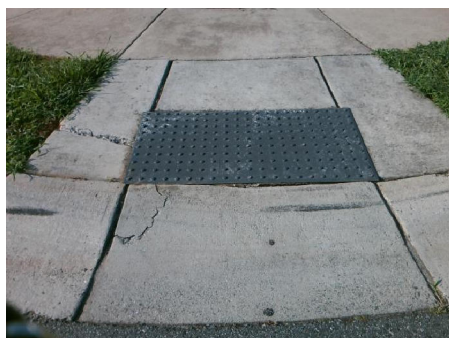
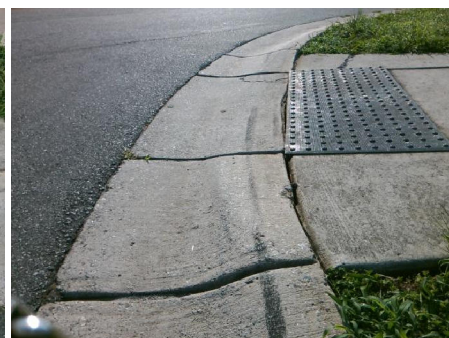
Compliance	Description	Data	Compliance	Description	Data
N/A	Ramp Length (in)	49.5	Yes	Ramp Slope (%)	7.8
No	Ramp Width (in)	41.0	Yes	Ramp XSlope (%)	1.2
N/A	Flare Type LT	N/A	N/A	Flare Type RT	N/A
N/A	Flare Slope LT (%)	N/A	N/A	Flare Slope RT (%)	N/A
N/A	Flare Traversable LT?	N/A	N/A	Flare Traversable RT?	N/A
N/A	Landing Length (in)	N/A	N/A	DWS Provided?	N/A
N/A	Landing Width (in)	N/A	N/A	DWS Contrast?	N/A
N/A	Landing Slope (%)	N/A	N/A	DWS Length (in)	N/A
N/A	Landing X Slope (%)	N/A	N/A	DWS Full Width?	N/A
N/A	Landing Curb? (Y/N)	N/A	N/A	DWS Offset (in)	N/A
N/A	Shared Landing?	N/A			
N/A	Gutter Ponding?	N/A	N/A	Gutter Slope (%)	N/A
N/A	Gutter Lip Ht (in)	N/A	N/A	Gutter X Slope (%)	N/A
N/A	Painted X Walk1?	No	N/A	Painted X Walk2?	No
	X Walk 1 Direction	To NE		X Walk 2 Direction	To NW
N/A	X Walk 1 Width (in)	N/A	N/A	X Walk 2 Width (in)	N/A
	X Walk 1 Slope (%)	1.0		X Walk 2 Slope (%)	1.7
	X Walk 1 X Slope (%)	0.0		X Walk 2 X Slope (%)	0.5

N/A	Ramp inside XWalk1?	N/A	N/A	Ramp inside XWalk2?	N/A
	Road Slope (%)	0.2	N/A	Clear Space?	N/A
	Road X Slope (%)	1.6	N/A	Clear Space to XWalk (in)	N/A
N/A	Any Obstructions?	N/A	N/A	Storm Grate/Utility Hazard?	N/A
	Obstruction Type			Storm Grate/Utility Type	
		N/A			N/A
		Yes		Surface Condition? (G/P)	Good

Remove & Replace Curb Ramp With Two New Directional Ramps or Equivalent.
