Access Compliance Report

Public Rights-of-Way

(Curb Ramps)

Intersection ID: 27404	Main Street: BALLANTYNE COMMONS PY	Cross Street: MEADOW RUN LN	Location: NW
ADA ID: 693D2014DABE	Ramp Type: Perp	Initial Pass/Fail: Fail	Overall Compliance: No
Severity Score: 21.25			
Codes/Mitigation Info/Possible Solution		Field Measurements/Component Compliance

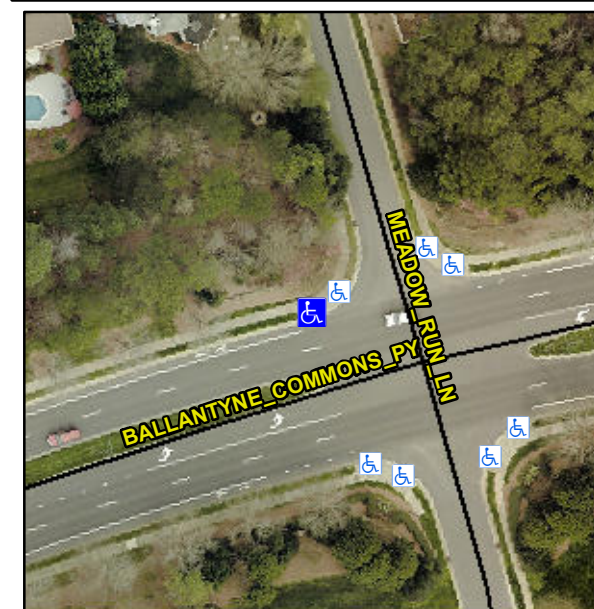
PROW/ADA:

Not Found, R304.5.1, R304.2.2

Compliance	Description	Data	Compliance	Description	Data
N/A	Ramp Length (in)	47.0	No	Ramp Slope (%)	8.4
No	Ramp Width (in)	43.0	Yes	Ramp XSlope (%)	1.0
N/A	Flare Type LT	N/A	N/A	Flare Type RT	N/A
N/A	Flare Slope LT (%)	N/A	N/A	Flare Slope RT (%)	N/A
N/A	Flare Traversable LT?	N/A	N/A	Flare Traversable RT?	N/A
N/A	Landing Length (in)	N/A	N/A	DWS Provided?	N/A
N/A	Landing Width (in)	N/A	N/A	DWS Contrast?	N/A
N/A	Landing Slope (%)	N/A	N/A	DWS Length (in)	N/A
N/A	Landing X Slope (%)	N/A	N/A	DWS Full Width?	N/A
N/A	Landing Curb? (Y/N)	N/A	N/A	DWS Offset (in)	N/A
N/A	Shared Landing?	N/A			
N/A	Gutter Ponding?	N/A	N/A	Gutter Slope (%)	N/A
N/A	Gutter Lip Ht (in)	N/A	N/A	Gutter X Slope (%)	N/A
N/A	Painted X Walk1?	No	N/A	Painted X Walk2?	N/A
	X Walk 1 Direction	To S		X Walk 2 Direction	N/A
N/A	X Walk 1 Width (in)	N/A	N/A	X Walk 2 Width (in)	N/A
	X Walk 1 Slope (%)	3.2		X Walk 2 Slope (%)	N/A
	X Walk 1 X Slope (%)	0.1		X Walk 2 X Slope (%)	N/A

N/A	Ramp inside XWalk1?	N/A	N/A	Ramp inside XWalk2?	N/A
	Road Slope (%)	N/A	N/A	Clear Space?	N/A
	Road X Slope (%)	N/A	N/A	Clear Space to XWalk (in)	N/A
N/A	Any Obstructions?	N/A	N/A	Storm Grate/Utility Hazard?	N/A
	Obstruction Type			Storm Grate/Utility Type	
		N/A			N/A
			Yes	Surface Condition? (G/P)	Good

Possible Solutions:

Remove & Replace Entire Ramp.
