# Access Compliance Report

## Public Rights-of-Way

| Intersection ID: 48499 | Main Street: CASTLECOVE_RD | Cross Street: MELFORT_WY | Location: NE |
| ADA ID: 694170E7EE33 | Ramp Type: PerpDiag | Initial Pass/Fail: Fail | Overall Compliance: No |

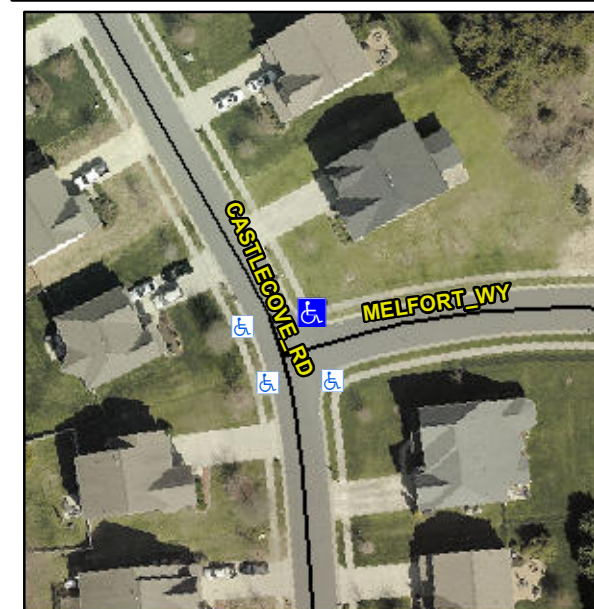
| Severity Score: 21.25 | | | |

| Compliance | Description | Data | Compliance | Description | Data |
|---|---|---|---|---|---|
| N/A | Ramp Length (in) | 54.0 | Yes | Ramp Slope (%) | 6.5 |
| No | Ramp Width (in) | 44.0 | No | Ramp XSlope (%) | 5.3 |

**Remove & Replace Curb Ramp With Two New Directional Ramps or Equivalent.**

**R304.5.1, R304.5.3**

Total Cost: \$ 3200.00
