Access Compliance Report

Public Rights-of-Way

(Curb Ramps)

Intersection ID: 13227		Main Street: SUNNYSIDE_AV		Cross Street: LAMAR_AV		Location: SE											
ADA ID: 694A12476100		Ramp Type: Directional1		Initial Pass/Fail: Fail		Overall Compliance: No		Severity Score: 12.5									
Codes/Mitigation Info/Possible Solution				Field Measurements/Component Compliance													
<div>

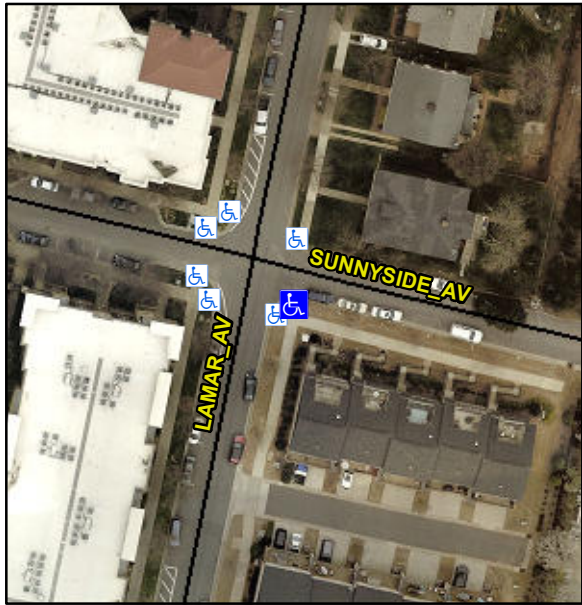
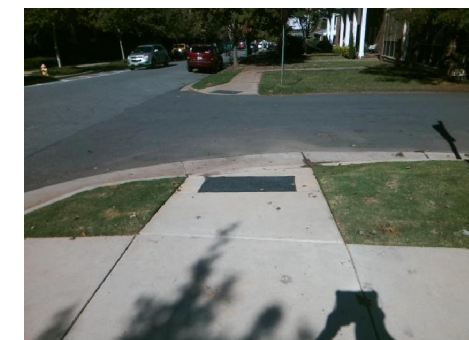
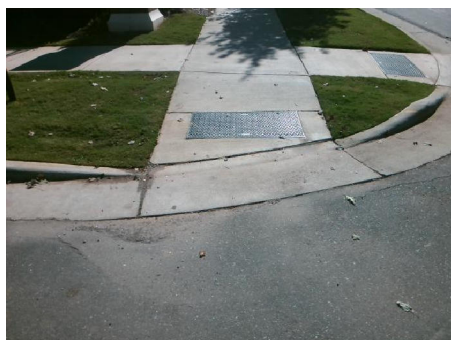
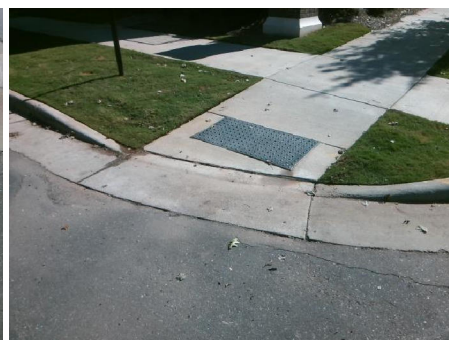
</div> <div>Possible Solutions:</div> <div>Remove & Replace Entire Ramp.</div> <div>Surveyor Notes:</div> <div>N/A</div> <div>PROW/ADA:</div> <div>R304.2.2</div> <div>Street 1 Name</div> <div>SUNNYSIDE AV</div> <div>Stop Condition-Street 1</div> <div>StopSign</div> <div>Street 2 Name</div> <div>N/A</div> <div>Stop Condition-Street 2</div> <div>N/A</div> <div>Total Cost:</div> <div>\$</div> <div>1600.00</div>				Compliance		Description		Data		Compliance		Description		Data			
				N/A		Ramp Length (in)		42.0		N/A		Grade Break?		N/A			
				Yes		Ramp Width (in)		73.0		N/A		Grade Break Slope (%)		0.0

No		Ramp Slope (%)		9.4		N/A		Grade Break XSlope (%)		0.0			
				Yes		Ramp XSlope (%)		1.7									
				N/A		Flare Type LT		N/A		N/A		Flare Type RT		N/A			
				N/A		Flare Slope LT (%)		N/A		N/A		Flare Slope RT (%)		0.0			
				N/A		Flare Traversable LT?		N/A		N/A		Flare Traversable RT?		N/A			
				N/A		Landing Length (in)		0.0		N/A		DWS Provided?		N/A			
				N/A		Landing Width (in)		0.0		N/A		DWS Contrast?		N/A			
				N/A		Landing Slope (%)		0.0		N/A		DWS Length (in)		N/A			
				N/A		Landing X Slope (%)		0.0		N/A		DWS Full Width?		N/A			
				N/A		Landing Curb? (Y/N)		N/A		N/A		DWS Offset LT (in)		N/A			
				N/A		Shared Landing?		N/A		N/A		DWS Offset RT (in)		N/A			
				N/A		Gutter Ponding?		0.0		N/A		Gutter Slope (%)		N/A			
				N/A		Gutter Lip Ht (in)		0.5		N/A		Gutter X Slope (%)		N/A			
				N/A		Painted X Walk1?		No				Road Slope (%)		0.6			
						X Walk 1 Direction		To N				Road X Slope (%)		0.7

X Walk 1 Width (in)		N/A				Clear Space?		N/A			
						X Walk 1 Slope (%)		0.6		N/A		Clear Space to XWalk (in)		N/A			
						X Walk 1 X Slope (%)		0.7		N/A		Storm Grate/Utility Hazard?		N/A			
				N/A		Ramp inside XWalk1?		N/A				Storm Grate/Utility Type					
				N/A		Any Obstructions?		N/A						N/A			
						Obstruction Type				Yes		Surface Condition? (G/P)		Good			
										N/A		N/A		Curb Slope (%)		3.7
