Access Compliance Report

Public Rights-of-Way

(Curb Ramps)

Intersection ID: 10025412	Main Street: E_CARSON_BV	Cross Street: N/A	Location: S
ADA ID: 695C47D0DCCE	Ramp Type: Perp	Initial Pass/Fail: Pass	Overall Compliance: No
		Severity Score: 0

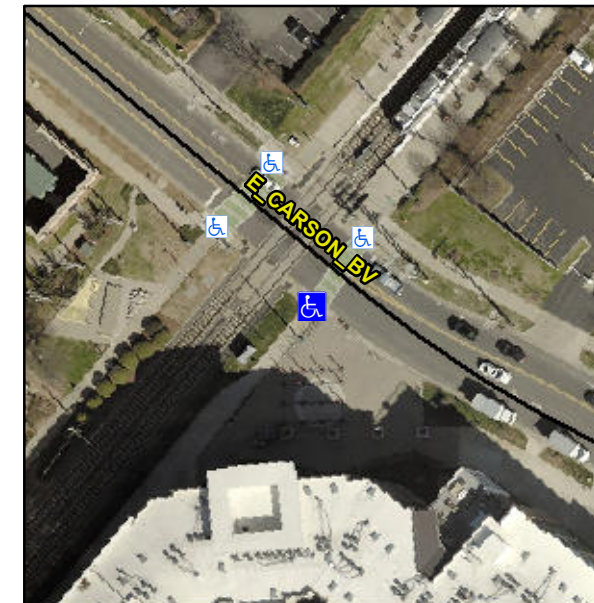
Not Found, R304.2.2-Perp, R304.3.2-Para

Compliance	Description	Data	Compliance	Description	Data
N/A	Ramp Length (in)	64.0	Yes	Ramp Slope (%)	5.9
Yes	Ramp Width (in)	95.0	Yes	Ramp XSlope (%)	1.2
N/A	Flare Type LT	Sloped	N/A	Flare Type RT	N/A
N/A	Flare Slope LT (%)	6.9	Yes	Flare Slope RT (%)	6.9
N/A	Flare Traversable LT?	Yes	N/A	Flare Traversable RT?	Yes
Yes	Landing Length (in)	57.0	Yes	DWS Provided?	Yes
Yes	Landing Width (in)	95.0	Yes	DWS Contrast?	Yes
No	Landing Slope (%)	3.0	Yes	DWS Length (in)	24.0
Yes	Landing X Slope (%)	0.4	Yes	DWS Full Width?	Yes
N/A	Landing Curb? (Y/N)	No	Yes	DWS Offset (in)	0.0
N/A	Shared Landing?	No			
Yes	Gutter Ponding?	No	Yes	Gutter Slope (%)	0.1
Yes	Gutter Lip Ht (in)	0.0	Yes	Gutter X Slope (%)	1.6
N/A	Painted X Walk1?	Yes	N/A	Painted X Walk2?	N/A
	X Walk 1 Direction	To NE		X Walk 2 Direction	N/A
N/A	X Walk 1 Width (in)	112.0	N/A	X Walk 2 Width (in)	N/A
	X Walk 1 Slope (%)	3.6		X Walk 2 Slope (%)	N/A
	X Walk 1 X Slope (%)	1.6		X Walk 2 X Slope (%)	N/A

Yes	Ramp inside XWalk1?	Yes	N/A	Ramp inside XWalk2?	N/A
	Road Slope (%)	N/A	N/A	Clear Space?	Yes
	Road X Slope (%)	N/A	N/A	Clear Space to XWalk (in)	N/A
Yes	Any Obstructions?	No	Yes	Storm Grate/Utility Hazard?	No
	Obstruction Type			Storm Grate/Utility Type	
		N/A			N/A
			Yes	Surface Condition? (G/P)	Good

Remove & Replace Entire Ramp.
