Access Compliance Report

Public Rights-of-Way

(Curb Ramps)

Intersection ID: 42765	Main Street: CRUTCHFIELD_PL	Cross Street: WINSTON_OAKS_CT	Location: NW
ADA ID: 695EAC358B30	Ramp Type: PerpDiag	Initial Pass/Fail: Fail	Overall Compliance: No
		Severity Score: 67.5

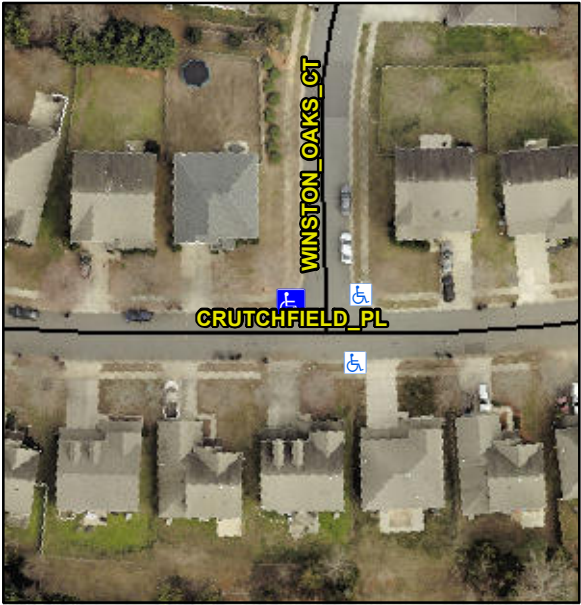
Possible Solutions:		Compliance	Description	Data
	Remove & Replace Curb Ramp With Two New Directional Ramps or Equivalent.		No	Ramp Length (in)	51.0
			No	Ramp Width (in)	35.0
			N/A	Flare Type LT	N/A
			N/A	Flare Slope LT (%)	N/A
			N/A	Flare Traversable LT?	N/A
			N/A	Landing Length (in)	N/A
			N/A	Landing Width (in)	N/A
			N/A	Landing Slope (%)	N/A
			N/A	Landing X Slope (%)	N/A
			N/A	Landing Curb? (Y/N)	N/A
			N/A	Shared Landing?	N/A
			N/A	Gutter Ponding?	N/A
			N/A	Gutter Lip Ht (in)	N/A
			No	Painted X Walk1?	No
				X Walk 1 Direction	To S
			N/A	X Walk 1 Width (in)	N/A
				X Walk 1 Slope (%)	10.3
				X Walk 1 X Slope (%)	6.7
			N/A	Ramp inside XWalk1?	N/A
<p>Surveyor Notes:</p> <p>N/A</p> <p>PROW/ADA:</p> <p>Not Found, R304.5.1, R304.2.2, R304.5.3</p>			N/A	Flare Type RT	N/A
			N/A	Flare Slope RT (%)	N/A
			N/A	Flare Traversable RT?	N/A

N/A	DWS Provided?	N/A
			N/A	DWS Contrast?	N/A
			N/A	DWS Length (in)	N/A
			N/A	DWS Full Width?	N/A
			N/A	DWS Offset (in)	N/A
			N/A	Gutter Slope (%)	N/A
			N/A	Gutter X Slope (%)	N/A
			No	Painted X Walk2?	No
				X Walk 2 Direction	To SE
			N/A	X Walk 2 Width (in)	N/A
				X Walk 2 Slope (%)	1.6
				X Walk 2 X Slope (%)	8.0
			N/A	Ramp inside XWalk2?	N/A
			N/A	Clear Space?	N/A
			N/A	Clear Space to XWalk (in)	N/A
			N/A	Storm Grate/Utility Hazard?	N/A
				Storm Grate/Utility Type	
			N/A		N/A
			Yes	Surface Condition? (G/P)	Good
Total Cost:		\$ 3200.00
