# Access Compliance Report

## Public Rights-of-Way

### (Curb Ramps)

| Intersection ID: 9091 | Main Street: GRANT_ST | Cross Street: MARIETTA_ST | Location: S |

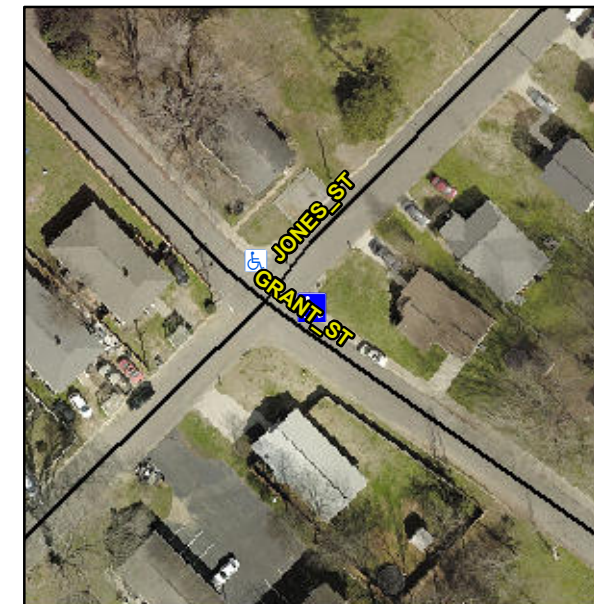
| ADA ID: 69642593E3FC | Ramp Type: Perp | Initial Pass/Fail: Fail | Overall Compliance: No |
| Severity Score: 10 | | | |

**Not Found, R304.5.1, R304.5.3**

| Compliance | Description | Data | Compliance | Description | Data |
|---|---|---|---|---|---|
| N/A | Ramp Length (in) | 41.5 | Yes | Ramp Slope (%) | 6.1 |
| No | Ramp Width (in) | 47.0 | No | Ramp XSlope (%) | 2.1 |

**Remove & Replace Entire Ramp.**

Total Cost: \$ 1850.00
