# Access Compliance Report

## Public Rights-of-Way

### (Curb Ramps)

| Intersection ID: 7834 | Main Street: BILMARK_AV | Cross Street: SNOW_WHITE_LN | Location: SE |

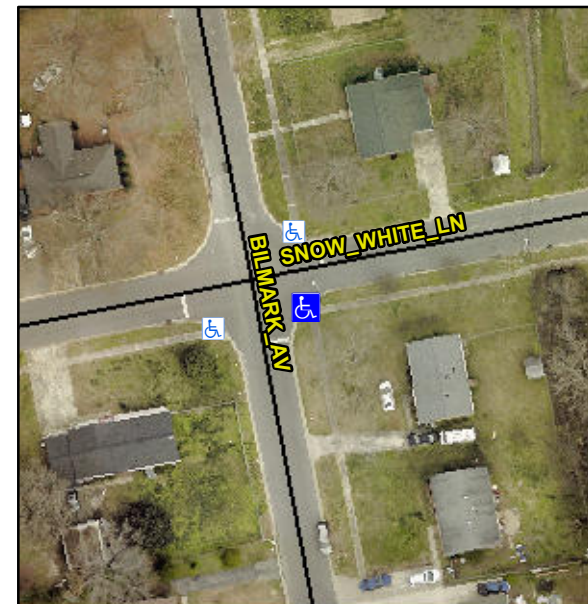
| ADA ID: 6966329B08B5 | Ramp Type: PerpDiag | Initial Pass/Fail: Pass | Overall Compliance: No |
| Severity Score: 14 | | | |

| Compliance | Description | Data | Compliance | Description | Data |
|---|---|---|---|---|---|
| No | Landing Length (in) | 43.5 | Yes | DWS Provided? | Yes |
| No | Landing Width (in) | 33.0 | Yes | DWS Contrast? | Yes |
| No | Landing Slope (%) | 6.1 | Yes | DWS Length (in) | 24.0 |
| Yes | Landing X Slope (%) | 0.3 | No | DWS Full Width? | No |
| N/A | Landing Curb? (Y/N) | No | No | DWS Offset (in) | 4.0 |
| No | Gutter Ponding? | Yes | Yes | Gutter Slope (%) | 2.4 |
| No | Gutter Lip Ht (in) | 0.5 | Yes | Gutter X Slope (%) | 0.2 |

Possible Solutions:

**Remove & Replace Curb Ramp With Two New Directional Ramps or Equivalent. Grind Gutter Lip.**

**R304.2.1, R304.2.2-Perp, R304.3.2-Para, R305.1.4, R305.2, R302.7, R302.7.2**

Total Cost: \$ **3400.00**
