# Access Compliance Report

## Public Rights-of-Way

### (Curb Ramps)

| Intersection ID: 45541 | Main Street: PEACHTREE_RD | Cross Street: HARRIER_RD | Location: SW |

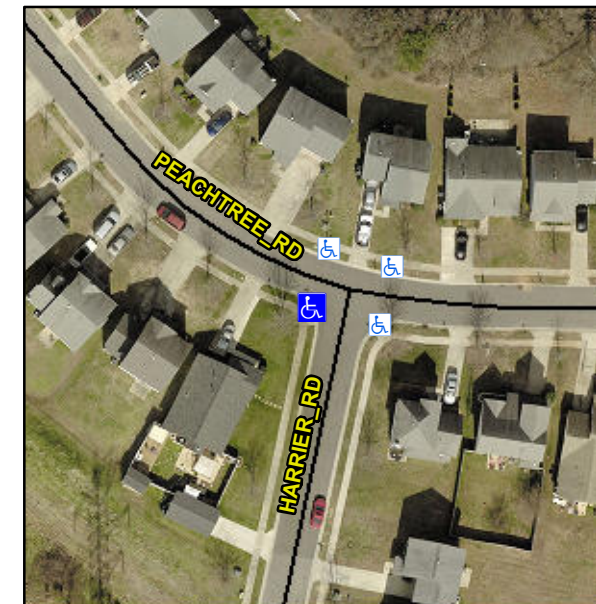
| ADA ID: 6966FB1EED5E | Ramp Type: BlendTrans2 | Initial Pass/Fail: Pass | Overall Compliance: No |
| Severity Score: 0.25 | | | |

**Not Found, R304.5.3, R305.2**

| Compliance | Description | Data | Compliance | Description | Data |
|---|---|---|---|---|---|
| Yes | Ramp Width (in) | 48.0 | No | BlendTrans XSlope (%) | 3.2 |
| N/A | Landing Curb? (Y/N) | No | No | DWS Offset (in) | 4.5 |
| Yes | Gutter Lip Ht (in) | 0.0 | No | Gutter X Slope (%) | 3.2 |
| | | | No | Curb Slope (%) | 15.2 |

Possible Solutions:

**Remove & Replace Curb Ramp With Two New Directional Ramps or Equivalent. Remove & Replace Gutter.**

Total Cost: \$ 3950.00

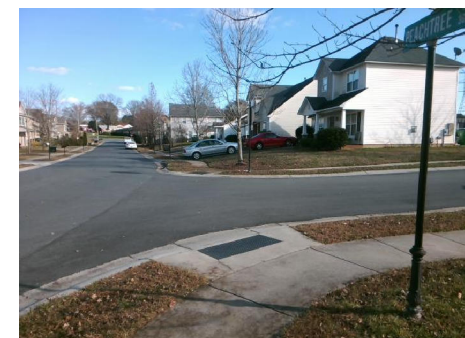
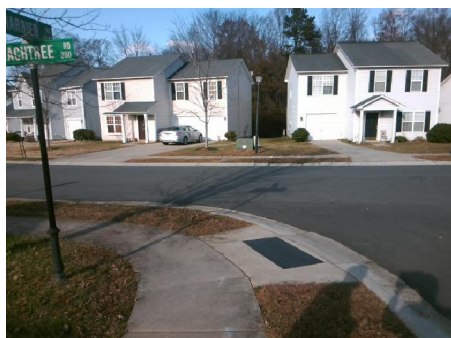
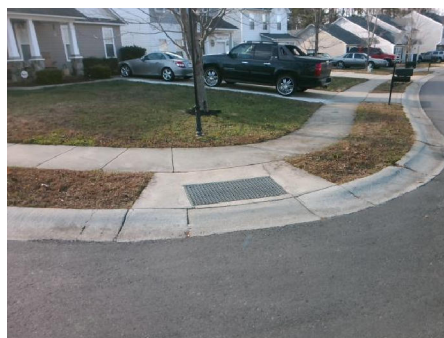
Street 1 Name **HARRIER RD**  
 Stop Condition-Street 1 **StopSign**  
 Street 2 Name **PEACHTREE RD**  
 Stop Condition-Street 2 **None**
