Access Compliance Report

Public Rights-of-Way

(Curb Ramps)

Intersection ID: 20951	Main Street: CROWNPOINT_EXECUTIVE_DR	Cross Street: E_INDEPENDENCE_BV	Location: SW
ADA ID: 69678828CBDC	Ramp Type: Perp	Initial Pass/Fail: Fail	Overall Compliance: No
Severity Score: 12.5			
Codes/Mitigation Info/Possible Solution		Field Measurements/Component Compliance

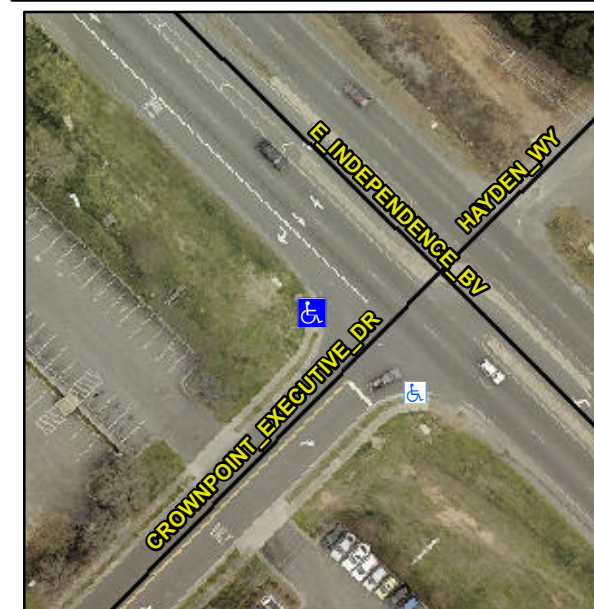
Not Found, R304.2.2

Compliance	Description	Data	Compliance	Description	Data
N/A	Ramp Length (in)	83.0	No	Ramp Slope (%)	11.7
Yes	Ramp Width (in)	48.0	Yes	Ramp XSlope (%)	0.1
N/A	Flare Type LT	N/A	N/A	Flare Type RT	N/A
N/A	Flare Slope LT (%)	N/A	N/A	Flare Slope RT (%)	N/A
N/A	Flare Traversable LT?	N/A	N/A	Flare Traversable RT?	N/A
N/A	Landing Length (in)	N/A	N/A	DWS Provided?	N/A
N/A	Landing Width (in)	N/A	N/A	DWS Contrast?	N/A
N/A	Landing Slope (%)	N/A	N/A	DWS Length (in)	N/A
N/A	Landing X Slope (%)	N/A	N/A	DWS Full Width?	N/A
N/A	Landing Curb? (Y/N)	N/A	N/A	DWS Offset (in)	N/A
N/A	Shared Landing?	N/A			
N/A	Gutter Ponding?	N/A	N/A	Gutter Slope (%)	N/A
N/A	Gutter Lip Ht (in)	N/A	N/A	Gutter X Slope (%)	N/A
N/A	Painted X Walk1?	No	N/A	Painted X Walk2?	N/A
	X Walk 1 Direction	To SE		X Walk 2 Direction	N/A
N/A	X Walk 1 Width (in)	N/A	N/A	X Walk 2 Width (in)	N/A
	X Walk 1 Slope (%)	2.2		X Walk 2 Slope (%)	N/A
	X Walk 1 X Slope (%)	2.5		X Walk 2 X Slope (%)	N/A

Remove & Replace Entire Ramp.
