Access Compliance Report

Public Rights-of-Way

(Curb Ramps)

Intersection ID: 3079	Main Street: BLACK_MAPLE_AV	Cross Street: PLACER_MAPLE_LN	Location: NE
ADA ID: 696D1A4015CD	Ramp Type: Perp	Initial Pass/Fail: Fail	Overall Compliance: No
Severity Score: 10			
Codes/Mitigation Info/Possible Solution		Field Measurements/Component Compliance

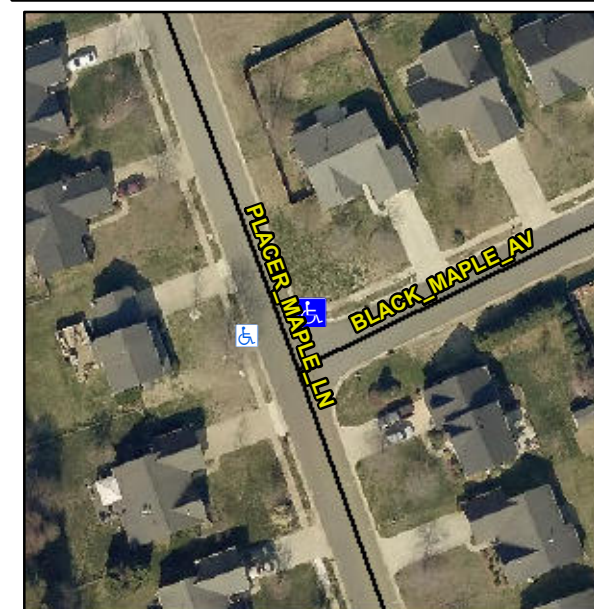
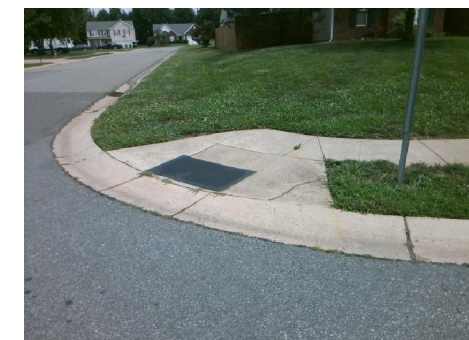
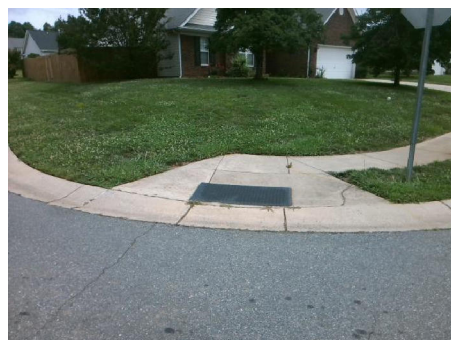
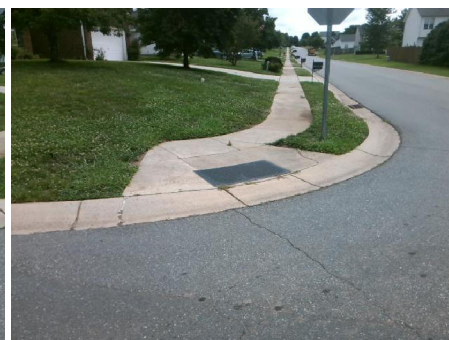
Compliance	Description	Data	Compliance	Description	Data
N/A	Ramp Length (in)	52.0	Yes	Ramp Slope (%)	5.5
No	Ramp Width (in)	42.0	No	Ramp XSlope (%)	3.1
N/A	Flare Type LT	N/A	N/A	Flare Type RT	N/A
N/A	Flare Slope LT (%)	N/A	N/A	Flare Slope RT (%)	N/A
N/A	Flare Traversable LT?	N/A	N/A	Flare Traversable RT?	N/A
N/A	Landing Length (in)	N/A	N/A	DWS Provided?	N/A
N/A	Landing Width (in)	N/A	N/A	DWS Contrast?	N/A
N/A	Landing Slope (%)	N/A	N/A	DWS Length (in)	N/A
N/A	Landing X Slope (%)	N/A	N/A	DWS Full Width?	N/A
N/A	Landing Curb? (Y/N)	N/A	N/A	DWS Offset (in)	N/A
N/A	Shared Landing?	N/A			
N/A	Gutter Ponding?	N/A	N/A	Gutter Slope (%)	N/A
N/A	Gutter Lip Ht (in)	N/A	N/A	Gutter X Slope (%)	N/A
N/A	Painted X Walk1?	No	N/A	Painted X Walk2?	N/A
	X Walk 1 Direction	To W		X Walk 2 Direction	N/A
N/A	X Walk 1 Width (in)	N/A	N/A	X Walk 2 Width (in)	N/A
	X Walk 1 Slope (%)	4.3		X Walk 2 Slope (%)	N/A
	X Walk 1 X Slope (%)	0.9		X Walk 2 X Slope (%)	N/A

N/A	Ramp inside XWalk1?	N/A	N/A	Ramp inside XWalk2?	N/A
	Road Slope (%)	N/A	N/A	Clear Space?	N/A
	Road X Slope (%)	N/A	N/A	Clear Space to XWalk (in)	N/A
N/A	Any Obstructions?	N/A	N/A	Storm Grate/Utility Hazard?	N/A
	Obstruction Type			Storm Grate/Utility Type	
		N/A			N/A
		Yes		Surface Condition? (G/P)	Good

Possible Solutions:

Remove & Replace Entire Ramp.

PROW/ADA:

R304.5.1, R304.5.3
