Access Compliance Report Public Rights-of-Way (Curb Ramps)

Intersection ID: 15173 Main Street: ALBEMARLE_RD Cross Street: EXECUTIVE_CENTER_DR Location: NE Severity Score: 21.25 ADA ID: 697092CDF307 Ramp Type: PerpDiag Initial Pass/Fail: Fail **Overall Compliance: No**

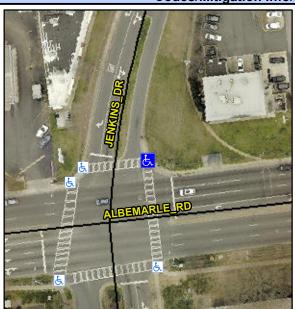
Field Measurements/Component Compliance							
Comp	liance Description	Data	Comp	liance Description	Data		
N/A	Ramp Length (in)	65.0	No	Ramp Slope (%)	8.6		
No	Ramp Width (in)	45.0	Yes	Ramp XSlope (%)	1.8		
N/A	Flare Type LT	N/A	N/A	Flare Type RT	N/A		
N/A	Flare Slope LT (%)	N/A	N/A	Flare Slope RT (%)	N/A		
N/A	Flare Traversable LT?	N/A	N/A	Flare Traversable RT?	N/A		
N/A	Landing Length (in)	N/A	N/A	DWS Provided?	N/A		
N/A	Landing Width (in)	N/A	N/A	DWS Contrast?	N/A		
N/A	Landing Slope (%)	N/A	N/A	DWS Length (in)	N/A		
N/A	Landing X Slope (%)	N/A	N/A	DWS Full Width?	N/A		
N/A	Landing Curb? (Y/N)	N/A	N/A	DWS Offset (in)	N/A		
N/A	Shared Landing?	N/A					
N/A	Gutter Ponding?	N/A	N/A	Gutter Slope (%)	N/A		
N/A	Gutter Lip Ht (in)	N/A	N/A	Gutter X Slope (%)	N/A		
N/A	Painted X Walk1?	Yes	N/A	Painted X Walk2?	Yes		
	X Walk 1 Direction	To SW		X Walk 2 Direction	To S		
N/A	X Walk 1 Width (in)	110.0	N/A	X Walk 2 Width (in)	92.0

X Walk 1 Slope (%)	0.9		X Walk 2 Slope (%)	2.9		
	X Walk 1 X Slope (%)	1.3		X Walk 2 X Slope (%)	1.0		
N/A	Ramp inside XWalk1?	Yes	N/A	Ramp inside XWalk2?	Yes		
	Road Slope (%)	2.3	N/A	Clear Space?	N/A		
	Road X Slope (%)	3.7	N/A	Clear Space to XWalk (in)	N/A		
N/A	Any Obstructions?	N/A	N/A	Storm Grate/Utility Hazard?	N/A		
	Obstruction Type			Storm Grate/Utility Type			
		N/A			N/A		
			Yes	Surface Condition? (G/P)	Good

/Possible Solution		
Possible Solutions:	9	
Remove & Replace Curb Ramp With Two New Directional Ramps or Equivalent.		
	!	
Surveyor Notes:	!	
	! !	
PROW/ADA:	i	
Not Found, R304.5.1, R304.2.2	1	
	ı

Fotal Cost:	\$ 3200.00
