# Access Compliance Report

## Public Rights-of-Way

### (Curb Ramps)

Intersection ID: 11170	Main Street: E_22ND_ST	Cross Street: N_DAVIDSON_ST	Location: N
ADA ID: 697B9F414B42	Ramp Type: Perp	Initial Pass/Fail: Fail	Overall Compliance: No
Severity Score: 21.25			
Codes/Mitigation Info/Possible Solution		Field Measurements/Component Compliance

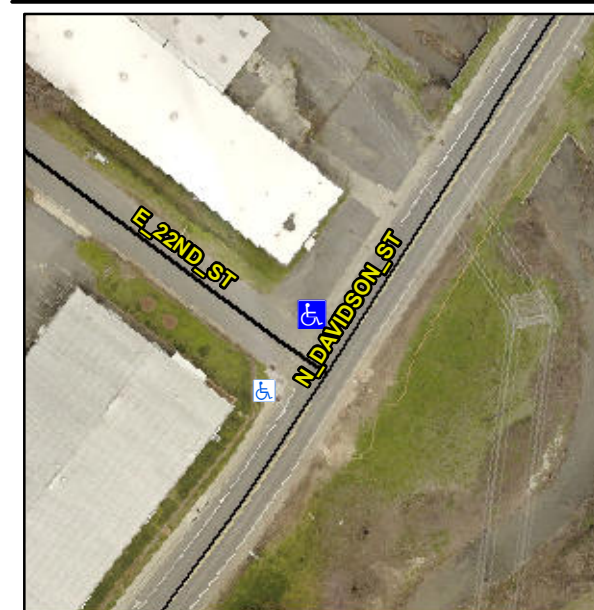
**Not Found, R304.5.1, R304.2.2**

Compliance	Description	Data	Compliance	Description	Data
N/A	Ramp Length (in)	48.0	No	Ramp Slope (%)	10.6
No	Ramp Width (in)	45.0	Yes	Ramp XSlope (%)	1.9
N/A	Flare Type LT	N/A	N/A	Flare Type RT	N/A
N/A	Flare Slope LT (%)	N/A	N/A	Flare Slope RT (%)	N/A
N/A	Flare Traversable LT?	N/A	N/A	Flare Traversable RT?	N/A
N/A	Landing Length (in)	N/A	N/A	DWS Provided?	N/A
N/A	Landing Width (in)	N/A	N/A	DWS Contrast?	N/A
N/A	Landing Slope (%)	N/A	N/A	DWS Length (in)	N/A
N/A	Landing X Slope (%)	N/A	N/A	DWS Full Width?	N/A
N/A	Landing Curb? (Y/N)	N/A	N/A	DWS Offset (in)	N/A
N/A	Shared Landing?	N/A			
N/A	Gutter Ponding?	N/A	N/A	Gutter Slope (%)	N/A
N/A	Gutter Lip Ht (in)	N/A	N/A	Gutter X Slope (%)	N/A
N/A	Painted X Walk1?	No	N/A	Painted X Walk2?	N/A
	X Walk 1 Direction	To SW		X Walk 2 Direction	N/A
N/A	X Walk 1 Width (in)	N/A	N/A	X Walk 2 Width (in)	N/A
	X Walk 1 Slope (%)	0.3		X Walk 2 Slope (%)	N/A
	X Walk 1 X Slope (%)	1.0		X Walk 2 X Slope (%)	N/A

N/A	Ramp inside XWalk1?	N/A	N/A	Ramp inside XWalk2?	N/A
	Road Slope (%)	N/A	N/A	Clear Space?	N/A
	Road X Slope (%)	N/A	N/A	Clear Space to XWalk (in)	N/A
N/A	Any Obstructions?	N/A	N/A	Storm Grate/Utility Hazard?	N/A
	Obstruction Type			Storm Grate/Utility Type	
		N/A			N/A
		Yes		Surface Condition? (G/P)	Good

**Remove & Replace Entire Ramp.**

Total Cost: \$ 1850.00
