# Access Compliance Report

## Public Rights-of-Way

### (Curb Ramps)

Intersection ID: 31481	Main Street: FLAGLER_LN	Cross Street: ROLETTE_CT	Location: SE
ADA ID: 697C27C22ACD	Ramp Type: PerpDiag	Initial Pass/Fail: Fail	Overall Compliance: No
Severity Score: 8.75			
Codes/Mitigation Info/Possible Solution		Field Measurements/Component Compliance

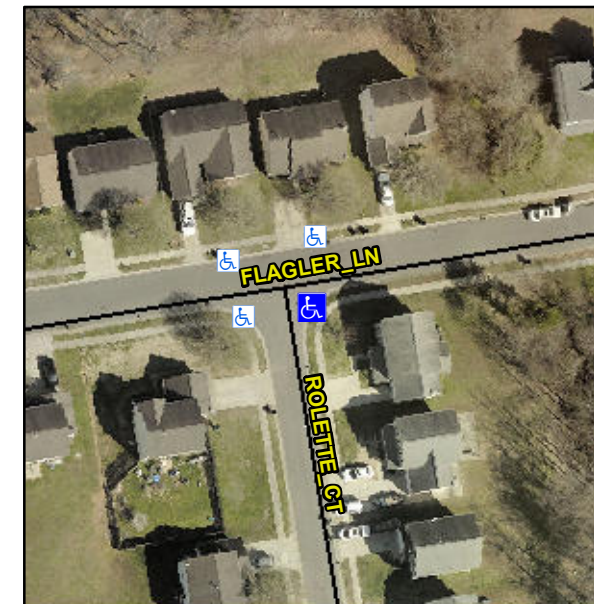
**Not Found, R304.5.1**

Compliance	Description	Data	Compliance	Description	Data
N/A	Ramp Length (in)	47.0	Yes	Ramp Slope (%)	7.8
No	Ramp Width (in)	38.5	Yes	Ramp XSlope (%)	0.8
N/A	Flare Type LT	N/A	N/A	Flare Type RT	N/A
N/A	Flare Slope LT (%)	N/A	N/A	Flare Slope RT (%)	N/A
N/A	Flare Traversable LT?	N/A	N/A	Flare Traversable RT?	N/A
N/A	Landing Length (in)	N/A	N/A	DWS Provided?	N/A
N/A	Landing Width (in)	N/A	N/A	DWS Contrast?	N/A
N/A	Landing Slope (%)	N/A	N/A	DWS Length (in)	N/A
N/A	Landing X Slope (%)	N/A	N/A	DWS Full Width?	N/A
N/A	Landing Curb? (Y/N)	N/A	N/A	DWS Offset (in)	N/A
N/A	Shared Landing?	N/A			
N/A	Gutter Ponding?	N/A	N/A	Gutter Slope (%)	N/A
N/A	Gutter Lip Ht (in)	N/A	N/A	Gutter X Slope (%)	N/A
N/A	Painted X Walk1?	No	N/A	Painted X Walk2?	No
	X Walk 1 Direction	To N		X Walk 2 Direction	To E
N/A	X Walk 1 Width (in)	N/A	N/A	X Walk 2 Width (in)	N/A
	X Walk 1 Slope (%)	3.0		X Walk 2 Slope (%)	3.7
	X Walk 1 X Slope (%)	3.2		X Walk 2 X Slope (%)	2.3

N/A	Ramp inside XWalk1?	N/A	N/A	Ramp inside XWalk2?	N/A
	Road Slope (%)	1.7	N/A	Clear Space?	N/A
	Road X Slope (%)	3.8	N/A	Clear Space to XWalk (in)	N/A
N/A	Any Obstructions?	N/A	N/A	Storm Grate/Utility Hazard?	N/A
	Obstruction Type			Storm Grate/Utility Type	
		N/A			N/A
		Yes		Surface Condition? (G/P)	Good

Possible Solutions:

**Remove & Replace Curb Ramp With Two New Directional Ramps or Equivalent.**

Total Cost: \$ 3200.00
