Access Compliance Report Public Rights-of-Way (Curb Ramps)

`````````````````````````````````										
Intersection ID: 9565	Main Street: N_TRYON_ST			reet:	W_32ND_ST	Location:	SW			
ADA ID: 6981113B6FF0	Ramp Ty	Ramp Type: PerpDiag			ail: Fail Overall (	o Severity Score:	35			
Codes/Mitigation Info/Possible Solution				Field Measurements/Component Compliance						
		Possible Solutions:		Compliance Description		Data Compliance Description			Data	
		Remove & Replace Curb Ramp W	ith	N/A	Ramp Length (in)	59.5	No	Ramp Slope (%)	15.6	
		Two New Directional Ramps or		No	Ramp Width (in)	46.0	No	Ramp XSlope (%)	4.5	
		Equivalent.	1	N/A	Flare Type LT	N/A	N/A	Flare Type RT	N/A	
			1	N/A	Flare Slope LT (%)	N/A	N/A	Flare Slope RT (%)	N/A	
6			1	N/A	Flare Traversable LT?	N/A	N/A	Flare Traversable RT?	N/A	
139	<mark>6.</mark>		1	N/A	Landing Length (in)	N/A	N/A	DWS Provided?	N/A	
5	F	Surveyor Notes:	1	N/A	Landing Width (in)	N/A	N/A	DWS Contrast?	N/A	
		N/A	1	N/A	Landing Slope (%)	N/A	N/A	DWS Length (in)	N/A

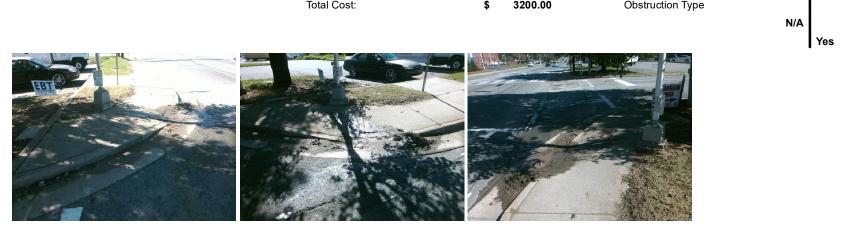
1	N/A	Landing X Slope (%)	N/A	N/A	DWS Full Width?	N/A	
			1	N/A	Landing Curb? (Y/N)	N/A	N/A	DWS Offset (in)	N/A	
		2	1	N/A	Shared Landing?	N/A				
1119 34		PROW/ADA:	1	N/A	Gutter Ponding?	Yes	N/A	Gutter Slope (%)	N/A	
101	1 634	Not Found, R304.5.1, R304.2.2,		N/A	Gutter Lip Ht (in)	N/A	N/A	Gutter X Slope (%)	N/A	
		R304.5.3	1	N/A	Painted X Walk1?	Yes	N/A	Painted X Walk2?	Yes	
					X Walk 1 Direction	To NE		X Walk 2 Direction	To NW	
			1	N/A	X Walk 1 Width (in)	111.0	N/A	X Walk 2 Width (in)	107.0	
Street 1 Name	W 32ND ST				X Walk 1 Slope (%)	1.6		X Walk 2 Slope (%)	3.6	
Stop Condition-Street 2	Signal				X Walk 1 X Slope (%)	3.4		X Walk 2 X Slope (%)	0.7	
Street 2 Name	N TRYON ST		1	N/A	Ramp inside XWalk1?	Yes	N/A	Ramp inside XWalk2?	Yes	
Stop Condition-Street 1	Signal				Road Slope (%)	0.5	N/A	Clear Space?	N/A

-				Road X Slope (%)	4.7	N/A	Clear Space to XWalk (in)	N/A	
				N/A	Any Obstructions?	N/A	N/A	Storm Grate/Utility Hazard?	N/A	
		Total Cost: \$ 32	00.00		Obstruction Type			Storm Grate/Utility Type
