Access Compliance Report

Public Rights-of-Way

(Curb Ramps)

Intersection ID: 10028935	Main Street: IDLEWILD_RD	Cross Street: N/A	Location: SW
ADA ID: 698841D8F144	Ramp Type: PerpDiag	Initial Pass/Fail: Fail	Overall Compliance: No
		Severity Score: 22.5

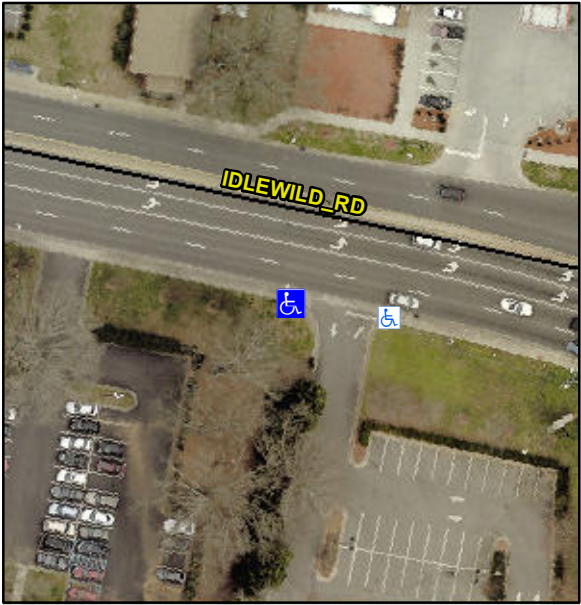
Possible Solutions:						
	Remove & Replace Curb Ramp With Two New Directional Ramps or Equivalent.	N/A	Ramp Length (in)	59.0	No	Ramp Slope (%)	10.8
		No	Ramp Width (in)	38.0	No	Ramp XSlope (%)	2.7
		N/A	Flare Type LT	N/A	N/A	Flare Type RT	N/A
		N/A	Flare Slope LT (%)	N/A	N/A	Flare Slope RT (%)	N/A
		N/A	Flare Traversable LT?	N/A	N/A	Flare Traversable RT?	N/A
		N/A	Landing Length (in)	N/A	N/A	DWS Provided?	N/A
		N/A	Landing Width (in)	N/A	N/A	DWS Contrast?	N/A
		N/A	Landing Slope (%)	N/A	N/A	DWS Length (in)	N/A
		N/A	Landing X Slope (%)	N/A	N/A	DWS Full Width?	N/A
		N/A	Landing Curb? (Y/N)	N/A	N/A	DWS Offset (in)	N/A
		N/A	Shared Landing?	N/A			
		N/A	Gutter Ponding?	N/A	N/A	Gutter Slope (%)	N/A
		N/A	Gutter Lip Ht (in)	N/A	N/A	Gutter X Slope (%)	N/A
		N/A	Painted X Walk1?	No	N/A	Painted X Walk2?	No
			X Walk 1 Direction	To SE		X Walk 2 Direction	To NE

N/A	X Walk 1 Width (in)	N/A	N/A	X Walk 2 Width (in)	N/A
			X Walk 1 Slope (%)	1.2		X Walk 2 Slope (%)	1.0
			X Walk 1 X Slope (%)	11.4		X Walk 2 X Slope (%)	1.7
		N/A	Ramp inside XWalk1?	N/A	N/A	Ramp inside XWalk2?	N/A
<p>Surveyor Notes:</p> <p>N/A</p> <p>PROW/ADA:</p> <p>Not Found, R304.5.1, R304.2.2, R304.5.3</p>							
			Road Slope (%)	2.8	N/A	Clear Space?	N/A
			Road X Slope (%)	0.5	N/A	Clear Space to XWalk (in)	N/A
		N/A	Any Obstructions?	N/A	N/A	Storm Grate/Utility Hazard?	N/A
			Obstruction Type			Storm Grate/Utility Type	
				N/A			N/A
					Yes	Surface Condition? (G/P)	Good
Street 1 Name	ENTRANCE						
Stop Condition-Street 2	StopSign						
Street 2 Name	IDLEWILD RD						
Stop Condition-Street 1	None						
Total Cost:	\$ 3200.00
