Access Compliance Report

Public Rights-of-Way

(Curb Ramps)

Intersection ID: 2897	Main Street: BELL'S_MILL_DR	Cross Street: HARBURN_FOREST_DR	Location: SW
ADA ID: 699A03E7DDCC	Ramp Type: PerpDiag	Initial Pass/Fail: Fail	Overall Compliance: No
Severity Score: 26.25			
Codes/Mitigation Info/Possible Solution		Field Measurements/Component Compliance

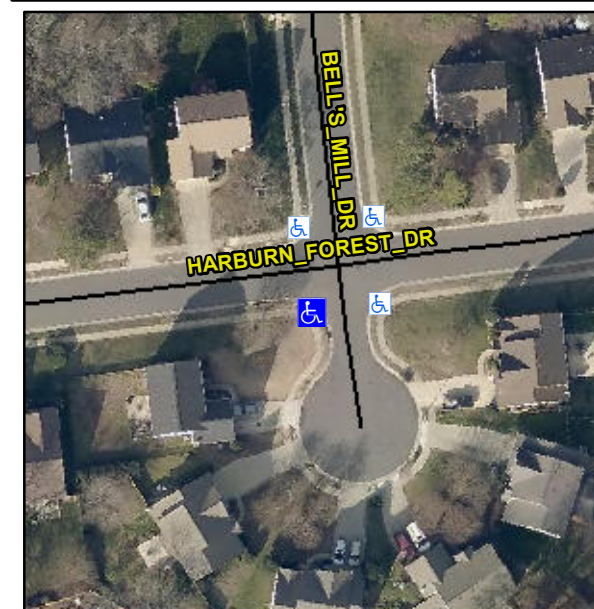
Not Found, R304.2.2, R304.5.3

Compliance	Description	Data	Compliance	Description	Data
N/A	Ramp Length (in)	48.0	No	Ramp Slope (%)	20.8
Yes	Ramp Width (in)	48.0	No	Ramp XSlope (%)	3.0
N/A	Flare Type LT	N/A	N/A	Flare Type RT	N/A
N/A	Flare Slope LT (%)	N/A	N/A	Flare Slope RT (%)	N/A
N/A	Flare Traversable LT?	N/A	N/A	Flare Traversable RT?	N/A
N/A	Landing Length (in)	N/A	N/A	DWS Provided?	N/A
N/A	Landing Width (in)	N/A	N/A	DWS Contrast?	N/A
N/A	Landing Slope (%)	N/A	N/A	DWS Length (in)	N/A
N/A	Landing X Slope (%)	N/A	N/A	DWS Full Width?	N/A
N/A	Landing Curb? (Y/N)	N/A	N/A	DWS Offset (in)	N/A
N/A	Shared Landing?	N/A			
N/A	Gutter Ponding?	N/A	N/A	Gutter Slope (%)	N/A
N/A	Gutter Lip Ht (in)	N/A	N/A	Gutter X Slope (%)	N/A
N/A	Painted X Walk1?	No	N/A	Painted X Walk2?	No
	X Walk 1 Direction	To E		X Walk 2 Direction	To N
N/A	X Walk 1 Width (in)	N/A	N/A	X Walk 2 Width (in)	N/A
	X Walk 1 Slope (%)	0.9		X Walk 2 Slope (%)	4.1
	X Walk 1 X Slope (%)	0.1		X Walk 2 X Slope (%)	2.5

N/A	Ramp inside XWalk1?	N/A	N/A	Ramp inside XWalk2?	N/A
	Road Slope (%)	2.8	N/A	Clear Space?	N/A
	Road X Slope (%)	2.5	N/A	Clear Space to XWalk (in)	N/A
N/A	Any Obstructions?	N/A	N/A	Storm Grate/Utility Hazard?	N/A
	Obstruction Type			Storm Grate/Utility Type	
		N/A			N/A
			Yes	Surface Condition? (G/P)	Good

Remove & Replace Curb Ramp With Two New Directional Ramps or Equivalent.
