# Access Compliance Report

## Public Rights-of-Way

| Intersection ID: 13960 | Main Street: CENTRAL_AV | Cross Street: KILBORNE_DR | Location: SW |
| ADA ID: 69A1DE1AA722 | Ramp Type: Perp | Initial Pass/Fail: Fail | Overall Compliance: No |

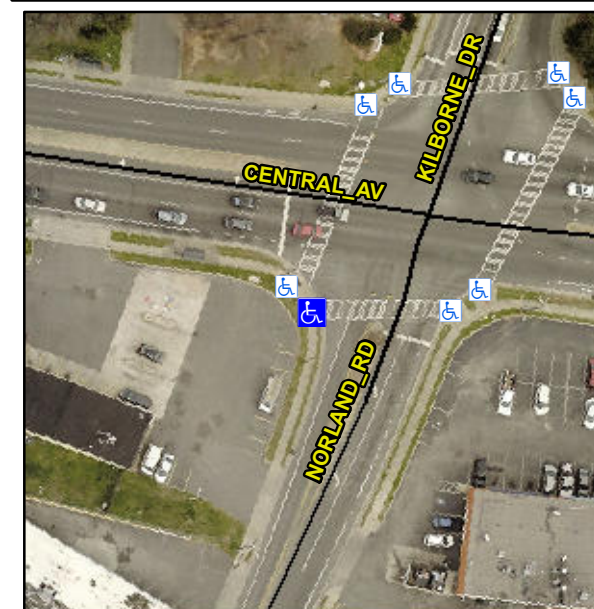
| Severity Score: 8.75 | | | |

**Not Found, R304.5.1**

| Compliance | Description | Data | Compliance | Description | Data |
|---|---|---|---|---|---|
| No | Ramp Width (in) | 45.0 | Yes | Ramp XSlope (%) | 0.5 |

**Remove & Replace Entire Ramp.**

Total Cost: \$ 1850.00
