Access Compliance Report

Public Rights-of-Way

(Curb Ramps)

Intersection ID: 31567	Main Street: MCCORD_ST	Cross Street: PEARL_CRESCENT_DR	Location:	N
ADA ID: 69B2624D7BDB	Ramp Type: PerpDiag	Initial Pass/Fail: Pass	Overall Compliance: No	Severity Score: 0
Codes/Mitigation Info/Possible Solution		Field Measurements/Component Compliance

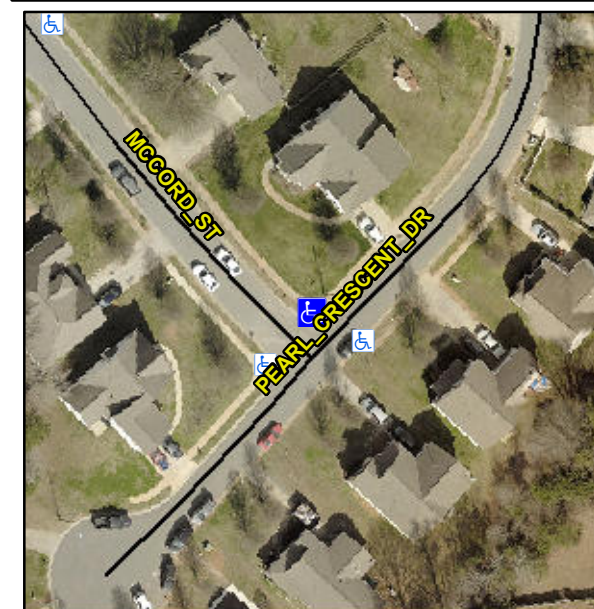
Not Found, R304.5.3

Compliance	Description	Data	Compliance	Description	Data
N/A	Ramp Length (in)	46.5	Yes	Ramp Slope (%)	5.6
Yes	Ramp Width (in)	48.0	Yes	Ramp XSlope (%)	1.5
N/A	Flare Type LT	Sloped	N/A	Flare Type RT	N/A
N/A	Flare Slope LT (%)	5.7	Yes	Flare Slope RT (%)	2.4
N/A	Flare Traversable LT?	Yes	N/A	Flare Traversable RT?	Yes
Yes	Landing Length (in)	52.0	Yes	DWS Provided?	Yes
Yes	Landing Width (in)	48.0	Yes	DWS Contrast?	Yes
Yes	Landing Slope (%)	0.4	Yes	DWS Length (in)	24.5
No	Landing X Slope (%)	4.0	Yes	DWS Full Width?	Yes
N/A	Landing Curb? (Y/N)	No	Yes	DWS Offset (in)	0.0
N/A	Shared Landing?	No			
Yes	Gutter Ponding?	No	Yes	Gutter Slope (%)	0.6
Yes	Gutter Lip Ht (in)	0.0	Yes	Gutter X Slope (%)	0.3
N/A	Painted X Walk1?	No	N/A	Painted X Walk2?	No
	X Walk 1 Direction	To SW		X Walk 2 Direction	To S
N/A	X Walk 1 Width (in)	N/A	N/A	X Walk 2 Width (in)	N/A
	X Walk 1 Slope (%)	1.8		X Walk 2 Slope (%)	1.6
	X Walk 1 X Slope (%)	2.7		X Walk 2 X Slope (%)	3.0

N/A	Ramp inside XWalk1?	N/A	N/A	Ramp inside XWalk2?	N/A
	Road Slope (%)	0.4	N/A	Clear Space?	Yes
	Road X Slope (%)	2.8	N/A	Clear Space to XWalk (in)	N/A
Yes	Any Obstructions?	No	Yes	Storm Grate/Utility Hazard?	No
	Obstruction Type			Storm Grate/Utility Type	
		N/A			N/A
			Yes	Surface Condition? (G/P)	Good

Possible Solutions:

Remove & Replace Curb Ramp With Two New Directional Ramps or Equivalent.

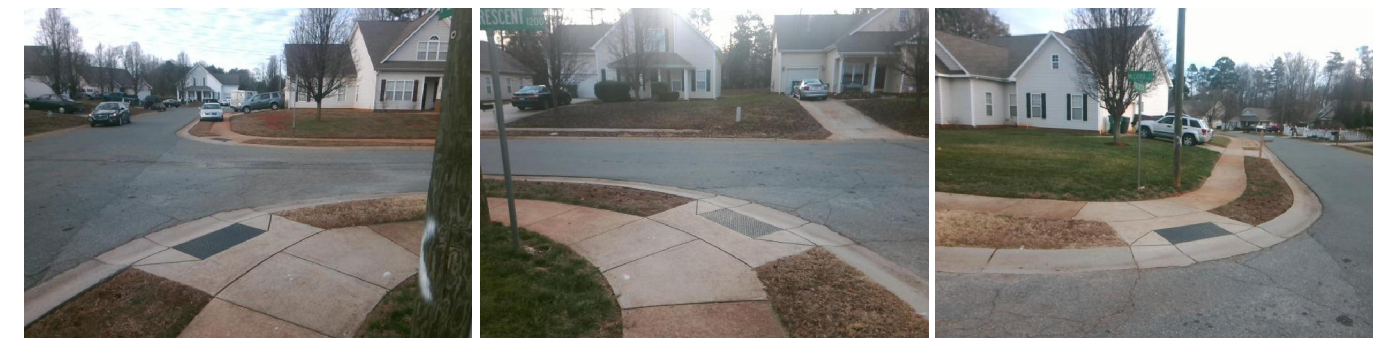
Street 1 Name MCCORD ST
 Stop Condition-Street 2 StopSign
 Street 2 Name PEARL CRESCENT DR
 Stop Condition-Street 1 None
