Access Compliance Report

Public Rights-of-Way

(Curb Ramps)

| Intersection ID: 10031454 | Main Street: MCDONALD_AV | Cross Street: N/A | Location: SW |

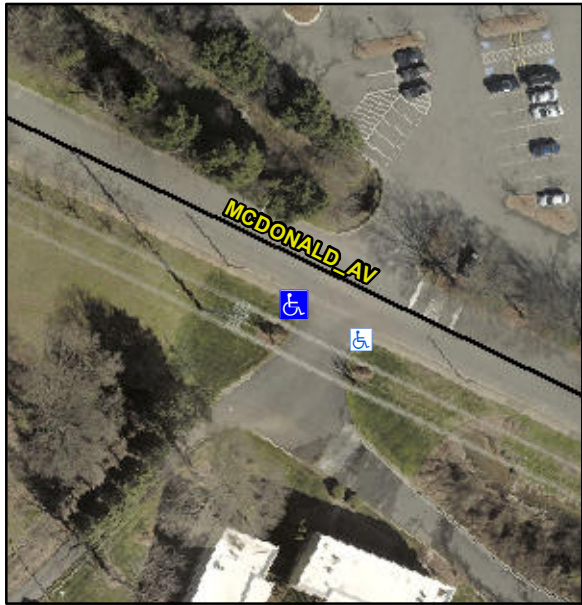
| ADA ID: 69BBF57B0739 | Ramp Type: Perp | Initial Pass/Fail: Fail | Overall Compliance: No |

| Codes/Mitigation Info/Possible Solution | | | Field Measurements/Component Compliance | | | | | |
|---|---|---|---|---|---|---|---|---|
| | Remove & Replace Entire Ramp. | | N/A | Ramp Length (in) | 47.0 | No | Ramp Slope (%) | 17.0 |
| | | | No | Ramp Width (in) | 46.0 | No | Ramp XSlope (%) | 10.8 |
| | Not Found, R304.5.1, R304.2.2, R304.5.3 | | N/A | Gutter Lip Ht (in) | 1.0 | N/A | Gutter X Slope (%) | N/A |
