Access Compliance Report

Public Rights-of-Way

(Curb Ramps)

Intersection ID: N/A	Main Street: TRYON_ST	Cross Street: NEVADA_BV	Location: E
ADA ID: 69C94F021A7D	Ramp Type: PerpDiag	Initial Pass/Fail: Fail	Overall Compliance: No
		Severity Score: 22.5

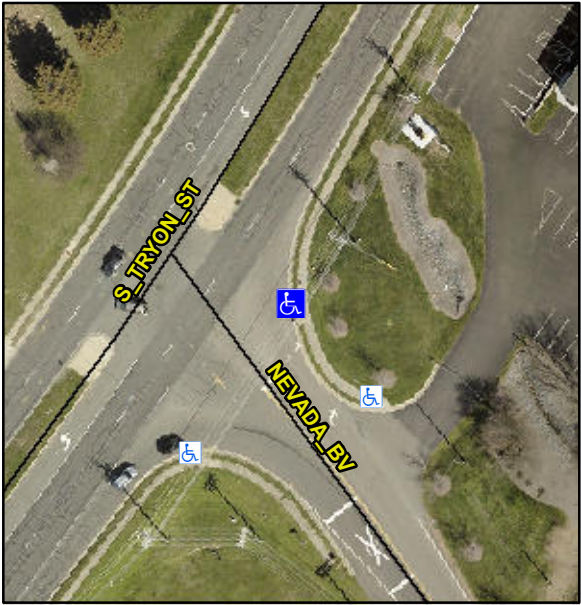
Possible Solutions:		Compliance	Description	Data
	Remove & Replace Curb Ramp With Two New Directional Ramps or Equivalent.		No	Ramp Length (in)	48.0
			No	Ramp Width (in)	47.0
			N/A	Flare Type LT	N/A
			N/A	Flare Slope LT (%)	N/A
			N/A	Flare Traversable LT?	N/A
			N/A	Landing Length (in)	N/A
			N/A	Landing Width (in)	N/A
			N/A	Landing Slope (%)	N/A
			N/A	Landing X Slope (%)	N/A
			N/A	Landing Curb? (Y/N)	N/A
			N/A	Shared Landing?	N/A
			N/A	Gutter Ponding?	N/A
			N/A	Gutter Lip Ht (in)	N/A
			No	Painted X Walk1?	N/A
				X Walk 1 Direction	To N
			N/A	X Walk 1 Width (in)	N/A
				X Walk 1 Slope (%)	0.7
				X Walk 1 X Slope (%)	2.8
			N/A	Ramp inside XWalk1?	N/A
<p>Surveyor Notes:</p> <p>N/A</p> <p>PROW/ADA:</p> <p>R304.5.1, R304.2.2, R304.5.3</p>			N/A	Flare Type RT	N/A
			N/A	Flare Slope RT (%)	N/A
			N/A	Flare Traversable RT?	N/A
