Access Compliance Report

Public Rights-of-Way

(Curb Ramps)

| Intersection ID: N/A | Main Street: WINGATE_AV | Cross Street: MAYFAIR_AV | Location: SE |

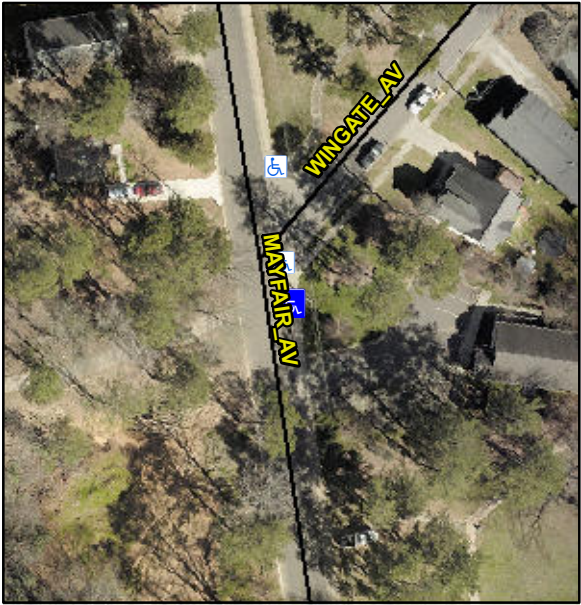
| ADA ID: 69D070096F2A | Ramp Type: Perp | Initial Pass/Fail: Fail | Overall Compliance: No |

| | Remove & Replace Entire Ramp. | N/A | Ramp Length (in) | 71.5 | No | Ramp Slope (%) | 8.4 |
| | | Yes | Ramp Width (in) | 48.0 | No | Ramp XSlope (%) | 3.8 |
| <p>Surveyor Notes:</p> <p>N/A</p> <p>PROW/ADA:</p> <p>Not Found, R304.2.2, R304.5.3</p> | | | Road Slope (%) | N/A | N/A | Clear Space? | N/A |

| | Possible Solutions: | Compliance | Description | Data | Compliance | Description | Data |
| <p>Total Cost:</p> <p>\$ 1850.00</p> | | N/A | Any Obstructions? | N/A | N/A | Storm Grate/Utility Hazard? | N/A |
