# Access Compliance Report

## Public Rights-of-Way

### (Curb Ramps)

| Intersection ID: 14621 | Main Street: KENMORE_AV | Cross Street: N_LAUREL_AV | Location: NW |

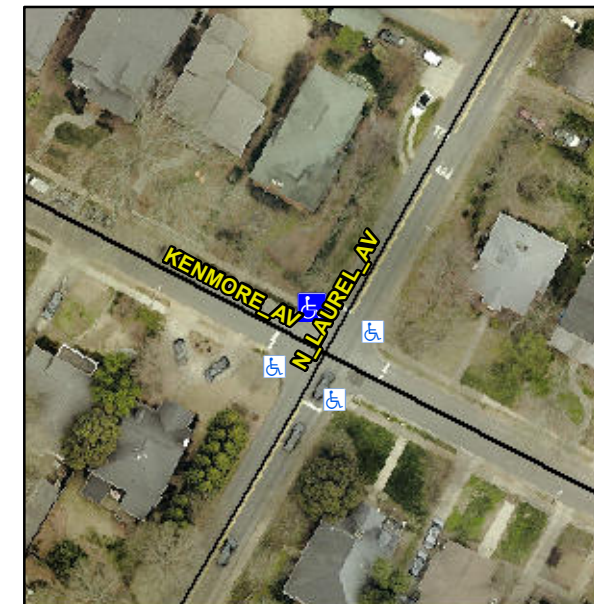
| ADA ID: 69D411D5272E | Ramp Type: PerpDiag | Initial Pass/Fail: Fail | Overall Compliance: No |
| | | Severity Score: 12.5 | |

**R304.5.3**

| Compliance | Description | Data | Compliance | Description | Data |
|---|---|---|---|---|---|
| N/A | Ramp Length (in) | 64.0 | Yes | Ramp Slope (%) | 5.4 |
| Yes | Ramp Width (in) | 48.0 | No | Ramp XSlope (%) | 5.3 |

**Remove & Replace Curb Ramp With Two New Directional Ramps or Equivalent.**

**\$ 3200.00**
