# Access Compliance Report

## Public Rights-of-Way

### (Curb Ramps)

Intersection ID: 14283	Main Street: AROSA_AV	Cross Street: DILWORTH_RD	Location: SE
ADA ID: 69D7FA6B01E3	Ramp Type: Directional1	Initial Pass/Fail: Fail	Overall Compliance: No
		Severity Score: 1.25

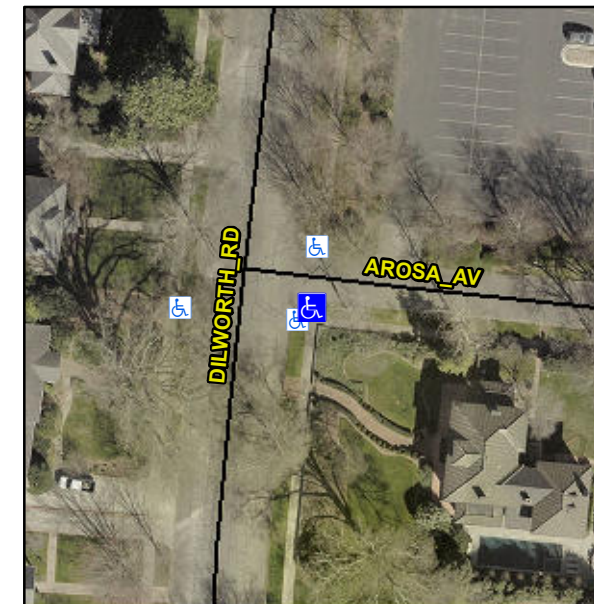
Compliance	Description	Data	Compliance	Description	Data
N/A	Ramp Length (in)	51.0	N/A	Grade Break?	N/A
Yes	Ramp Width (in)	48.0	N/A	Grade Break Slope (%)	0.0
Yes	Ramp Slope (%)	5.2	N/A	Grade Break XSlope (%)	0.0
No	Ramp XSlope (%)	2.5			
N/A	Flare Type LT	N/A	N/A	Flare Type RT	N/A
N/A	Flare Slope LT (%)	N/A	N/A	Flare Slope RT (%)	0.0
N/A	Flare Traversable LT?	N/A	N/A	Flare Traversable RT?	N/A
N/A	Landing Length (in)	0.0	N/A	DWS Provided?	N/A
N/A	Landing Width (in)	0.0	N/A	DWS Contrast?	N/A
N/A	Landing Slope (%)	0.0	N/A	DWS Length (in)	N/A
N/A	Landing X Slope (%)	0.0	N/A	DWS Full Width?	N/A
N/A	Landing Curb? (Y/N)	N/A	N/A	DWS Offset LT (in)	N/A
N/A	Shared Landing?	N/A	N/A	DWS Offset RT (in)	N/A
N/A	Gutter Ponding?	0.0	N/A	Gutter Slope (%)	N/A
N/A	Gutter Lip Ht (in)	0.0	N/A	Gutter X Slope (%)	N/A
N/A	Painted X Walk1?	No		Road Slope (%)	7.3
	X Walk 1 Direction	To N		Road X Slope (%)	1.8
	X Walk 1 Width (in)	N/A		Clear Space?	N/A

X Walk 1 Slope (%)	7.3	N/A	Clear Space to XWalk (in)	N/A
	X Walk 1 X Slope (%)	1.8	N/A	Storm Grate/Utility Hazard?	N/A
N/A	Ramp inside XWalk1?	N/A		Storm Grate/Utility Type	
N/A	Any Obstructions?	N/A			N/A
	Obstruction Type		Yes	Surface Condition? (G/P)	Good
			N/A	Curb Slope (%)	5.8

**Remove & Replace Entire Ramp.**

**R304.5.3**
