# Access Compliance Report

## Public Rights-of-Way

Intersection ID: 22192	Main Street: MOORELAND_FARMS_RD	Cross Street: CARMEL_RD	Location: S
ADA ID: 69DB81EE38DF	Ramp Type: PerpDiag	Initial Pass/Fail: Fail	Overall Compliance: No
Severity Score: 13.75			
Codes/Mitigation Info/Possible Solution		Field Measurements/Component Compliance

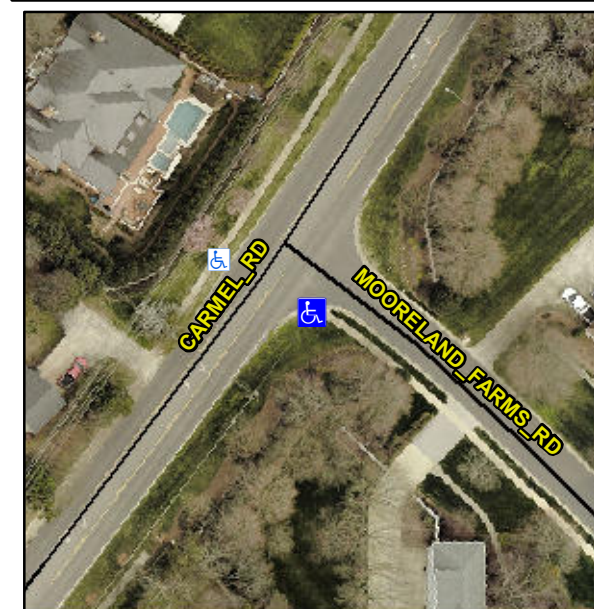
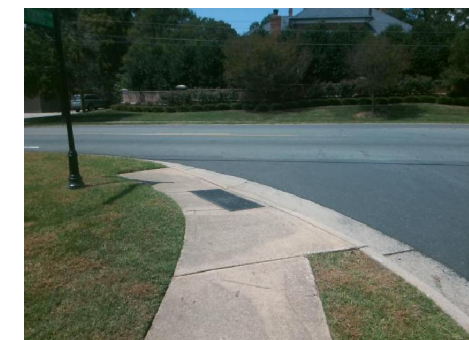
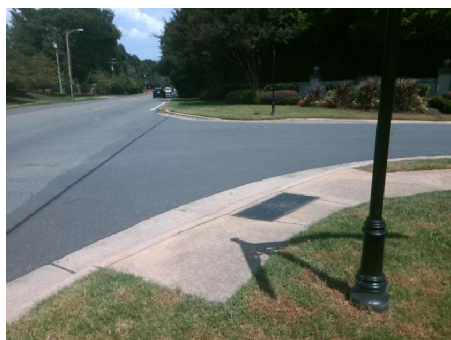
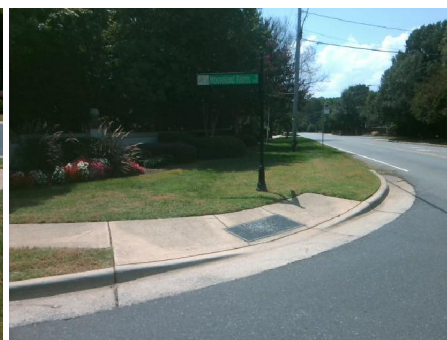
**Not Found, R304.2.2, R304.5.3**

Compliance	Description	Data	Compliance	Description	Data
N/A	Ramp Length (in)	48.0	No	Ramp Slope (%)	9.1
Yes	Ramp Width (in)	48.0	No	Ramp XSlope (%)	3.3
N/A	Flare Type LT	N/A	N/A	Flare Type RT	N/A
N/A	Flare Slope LT (%)	N/A	N/A	Flare Slope RT (%)	N/A
N/A	Flare Traversable LT?	N/A	N/A	Flare Traversable RT?	N/A
N/A	Landing Length (in)	N/A	N/A	DWS Provided?	N/A
N/A	Landing Width (in)	N/A	N/A	DWS Contrast?	N/A
N/A	Landing Slope (%)	N/A	N/A	DWS Length (in)	N/A
N/A	Landing X Slope (%)	N/A	N/A	DWS Full Width?	N/A
N/A	Landing Curb? (Y/N)	N/A	N/A	DWS Offset (in)	N/A
N/A	Shared Landing?	N/A			
N/A	Gutter Ponding?	N/A	N/A	Gutter Slope (%)	N/A
N/A	Gutter Lip Ht (in)	N/A	N/A	Gutter X Slope (%)	N/A
N/A	Painted X Walk1?	No	N/A	Painted X Walk2?	No
	X Walk 1 Direction	To NE		X Walk 2 Direction	To NW
N/A	X Walk 1 Width (in)	N/A	N/A	X Walk 2 Width (in)	N/A
	X Walk 1 Slope (%)	1.2		X Walk 2 Slope (%)	4.3
	X Walk 1 X Slope (%)	3.5		X Walk 2 X Slope (%)	1.9

N/A	Ramp inside XWalk1?	N/A	N/A	Ramp inside XWalk2?	N/A
	Road Slope (%)	1.7	N/A	Clear Space?	N/A
	Road X Slope (%)	4.9	N/A	Clear Space to XWalk (in)	N/A
N/A	Any Obstructions?	N/A	N/A	Storm Grate/Utility Hazard?	N/A
	Obstruction Type			Storm Grate/Utility Type	
		N/A			N/A
			Yes	Surface Condition? (G/P)	Good

**Remove & Replace Curb Ramp With Two New Directional Ramps or Equivalent.**
