Access Compliance Report

Public Rights-of-Way

(Curb Ramps)

Intersection ID: 10034609	Main Street: PLANTATION_CENTER_DR	Cross Street: N/A	Location: NE
ADA ID: 69DC05B8697C	Ramp Type: Para	Initial Pass/Fail: Fail	Overall Compliance: No
Codes/Mitigation Info/Possible Solution		Field Measurements/Component Compliance	
Severity Score: 26.25

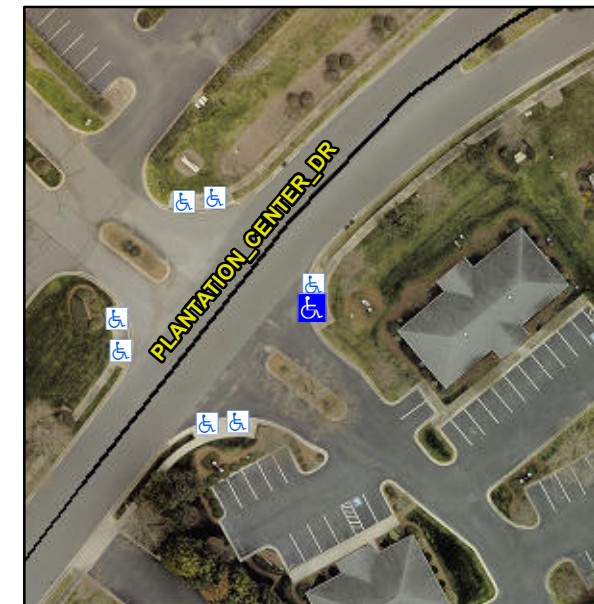
R304.3.2, R304.5.3

Compliance	Description	Data	Compliance	Description	Data
N/A	Ramp Length LT (in)	48.0	N/A	Ramp Length RT (in)	47.0
Yes	Ramp Width LT (in)	108.0	Yes	Ramp Width RT (in)	108.0
No	Ramp Slope LT (%)	12.4	No	Ramp Slope RT (%)	13.7
No	Ramp XSlope LT (%)	2.6	No	Ramp XSlope RT (%)	2.2
N/A	Landing Length (in)	N/A	N/A	DWS Provided?	N/A
N/A	Landing Width (in)	N/A	N/A	DWS Contrast?	N/A
N/A	Landing Slope (%)	N/A	N/A	DWS Length (in)	N/A
N/A	Landing X Slope (%)	N/A	N/A	DWS Full Width?	N/A
N/A	Landing Curb? (Y/N)	N/A	N/A	DWS Offset (in)	N/A
N/A	Shared Landing?	N/A			
N/A	Gutter Ponding?	N/A	N/A	Gutter Slope (%)	N/A
N/A	Gutter Lip Ht (in)	N/A	N/A	Gutter X Slope (%)	N/A
N/A	Painted X Walk1?	No	N/A	Painted X Walk2?	N/A
	X Walk 1 Direction	To SW		X Walk 2 Direction	N/A
N/A	X Walk 1 Width (in)	N/A	N/A	X Walk 2 Width (in)	N/A
	X Walk 1 Slope (%)	0.8		X Walk 2 Slope (%)	N/A
	X Walk 1 X Slope (%)	1.6		X Walk 2 X Slope (%)	N/A
N/A	Ramp inside XWalk1?	N/A	N/A	Ramp inside XWalk2?	N/A

Road Slope (%)	N/A	N/A	Clear Space?	N/A
	Road X Slope (%)	N/A	N/A	Clear Space to XWalk (in)	N/A
N/A	Any Obstructions?	N/A	N/A	Storm Grate/Utility Hazard?	N/A
	Obstruction Type			Storm Grate/Utility Type	
		N/A			N/A
			Yes	Surface Condition? (G/P)	Good
			N/A	Curb Slope (%)	6.0

Remove & Replace Entire Ramp.
