Access Compliance Report

Public Rights-of-Way

(Curb Ramps)

Intersection ID: 14127	Main Street: BASCOM_ST	Cross Street: BAY_ST	Location: NW
ADA ID: 69E27052D752	Ramp Type: Perp	Initial Pass/Fail: Fail	Overall Compliance: No
Severity Score: 10			
Codes/Mitigation Info/Possible Solution		Field Measurements/Component Compliance

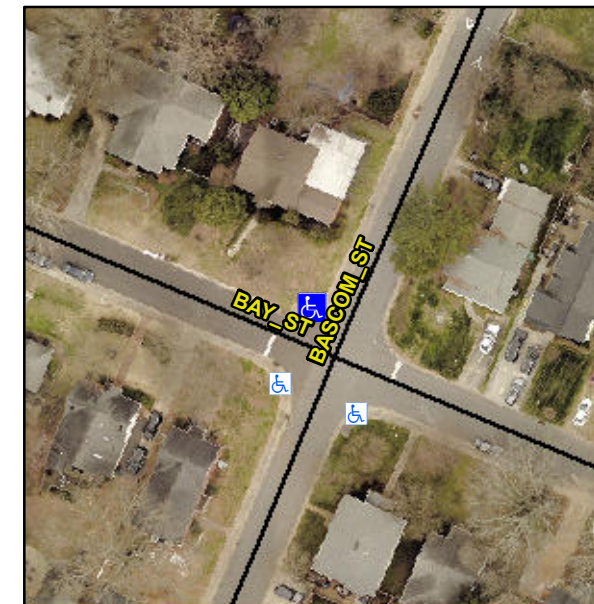
Compliance	Description	Data	Compliance	Description	Data
N/A	Ramp Length (in)	60.0	Yes	Ramp Slope (%)	6.7
No	Ramp Width (in)	47.0	No	Ramp XSlope (%)	3.6
N/A	Flare Type LT	N/A	N/A	Flare Type RT	N/A
N/A	Flare Slope LT (%)	N/A	N/A	Flare Slope RT (%)	N/A
N/A	Flare Traversable LT?	N/A	N/A	Flare Traversable RT?	N/A
N/A	Landing Length (in)	N/A	N/A	DWS Provided?	N/A
N/A	Landing Width (in)	N/A	N/A	DWS Contrast?	N/A
N/A	Landing Slope (%)	N/A	N/A	DWS Length (in)	N/A
N/A	Landing X Slope (%)	N/A	N/A	DWS Full Width?	N/A
N/A	Landing Curb? (Y/N)	N/A	N/A	DWS Offset (in)	N/A
N/A	Shared Landing?	N/A			
N/A	Gutter Ponding?	Yes	N/A	Gutter Slope (%)	N/A
N/A	Gutter Lip Ht (in)	0.5	N/A	Gutter X Slope (%)	N/A
N/A	Painted X Walk1?	No	N/A	Painted X Walk2?	N/A
	X Walk 1 Direction	To SW		X Walk 2 Direction	N/A
N/A	X Walk 1 Width (in)	N/A	N/A	X Walk 2 Width (in)	N/A
	X Walk 1 Slope (%)	4.2		X Walk 2 Slope (%)	N/A
	X Walk 1 X Slope (%)	0.5		X Walk 2 X Slope (%)	N/A

N/A	Ramp inside XWalk1?	N/A	N/A	Ramp inside XWalk2?	N/A
	Road Slope (%)	N/A	N/A	Clear Space?	N/A
	Road X Slope (%)	N/A	N/A	Clear Space to XWalk (in)	N/A
N/A	Any Obstructions?	N/A	N/A	Storm Grate/Utility Hazard?	N/A
	Obstruction Type			Storm Grate/Utility Type	
		N/A			N/A
		Yes		Surface Condition? (G/P)	Good

Possible Solutions:

Remove & Replace Entire Ramp.

R304.5.1, R304.5.3
