## **Access Compliance Report Public Rights-of-Way** (Curb Ramps)

Main Street: KELVIN PARK CR Intersection ID: 5093 **Cross Street: PENNYCROSS LN** Location: SE **Overall Compliance: No ADA ID: 69EAB3571C5C** Ramp Type: Combination1 Initial Pass/Fail: Fail Severity Score: 21.25

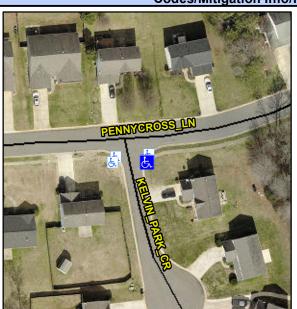
Possible Solutions: Compliance Description N/A Remove & Replace Entire Ramp. No Yes No N/A No Surveyor Notes: N/A **RT RP < 5%** N/A N/A N/A N/A PROW/ADA: N/A R304.5.1, R304.5.1, R304.5.3 N/A N/A N/A N/A N/A N/A
