Access Compliance Report

Public Rights-of-Way

(Curb Ramps)

Intersection ID: 48884	Main Street: REINBECK_DR	Cross Street: OLD_POTTERS_RD	Location: S
ADA ID: 69EE3FB547B0	Ramp Type: Perp	Initial Pass/Fail: Fail	Overall Compliance: No
Severity Score: 21.25			
Codes/Mitigation Info/Possible Solution		Field Measurements/Component Compliance

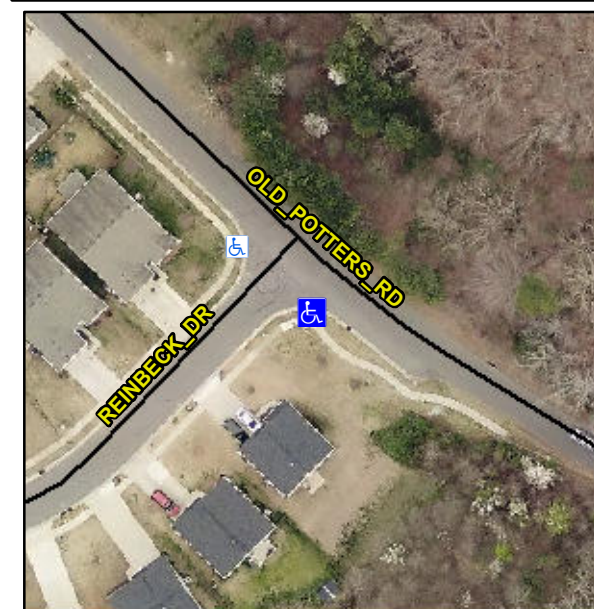
Not Found, R304.5.1, R304.5.3

Compliance	Description	Data	Compliance	Description	Data
N/A	Ramp Length (in)	45.0	Yes	Ramp Slope (%)	7.5
No	Ramp Width (in)	46.0	No	Ramp XSlope (%)	6.7
N/A	Flare Type LT	N/A	N/A	Flare Type RT	N/A
N/A	Flare Slope LT (%)	N/A	N/A	Flare Slope RT (%)	N/A
N/A	Flare Traversable LT?	N/A	N/A	Flare Traversable RT?	N/A
N/A	Landing Length (in)	N/A	N/A	DWS Provided?	N/A
N/A	Landing Width (in)	N/A	N/A	DWS Contrast?	N/A
N/A	Landing Slope (%)	N/A	N/A	DWS Length (in)	N/A
N/A	Landing X Slope (%)	N/A	N/A	DWS Full Width?	N/A
N/A	Landing Curb? (Y/N)	N/A	N/A	DWS Offset (in)	N/A
N/A	Shared Landing?	N/A			
N/A	Gutter Ponding?	N/A	N/A	Gutter Slope (%)	N/A
N/A	Gutter Lip Ht (in)	N/A	N/A	Gutter X Slope (%)	N/A
N/A	Painted X Walk1?	No	N/A	Painted X Walk2?	N/A
	X Walk 1 Direction	To NW		X Walk 2 Direction	N/A
N/A	X Walk 1 Width (in)	N/A	N/A	X Walk 2 Width (in)	N/A
	X Walk 1 Slope (%)	7.5		X Walk 2 Slope (%)	N/A
	X Walk 1 X Slope (%)	0.4		X Walk 2 X Slope (%)	N/A

N/A	Ramp inside XWalk1?	N/A	N/A	Ramp inside XWalk2?	N/A
	Road Slope (%)	N/A	N/A	Clear Space?	N/A
	Road X Slope (%)	N/A	N/A	Clear Space to XWalk (in)	N/A
N/A	Any Obstructions?	N/A	N/A	Storm Grate/Utility Hazard?	N/A
	Obstruction Type			Storm Grate/Utility Type	
		N/A			N/A
			Yes	Surface Condition? (G/P)	Good

Possible Solutions:

Remove & Replace Entire Ramp.

Total Cost: \$ 1850.00
